## **CONGLETON TOWN COUNCIL**

| <b>REPORT FROM</b> | <b>Town Hall Manager – Mark Worthington</b> | | |
| <b>REPORT TITLE</b> | <b>Roof Repairs Drone Survey (i)</b> | | |

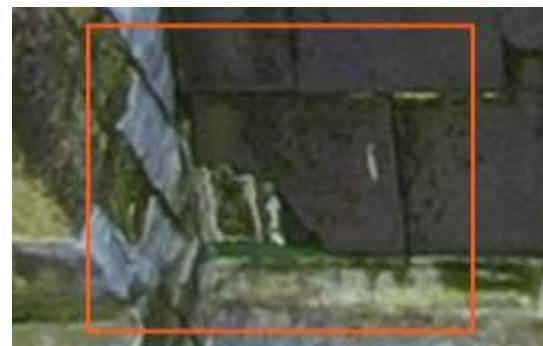
2673928 Severity: 3 Damaged Slate

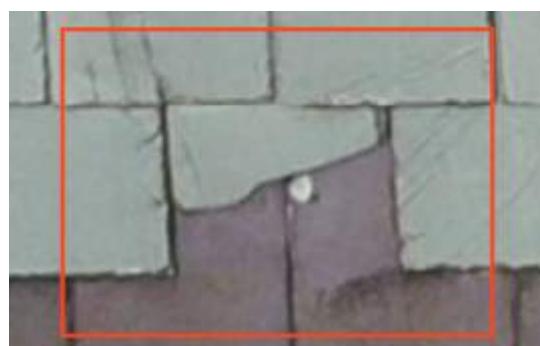
2673947 Severity: 4 Damaged Slate

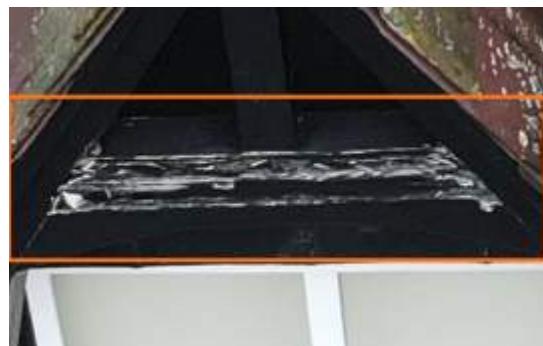
2673959 Severity: 2 Paint Coat Failed

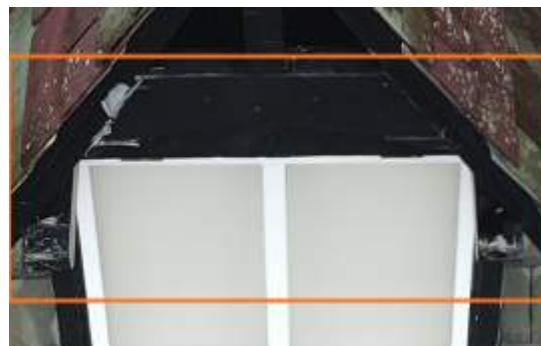
2673966 Severity: 2 Paint Coat Failed

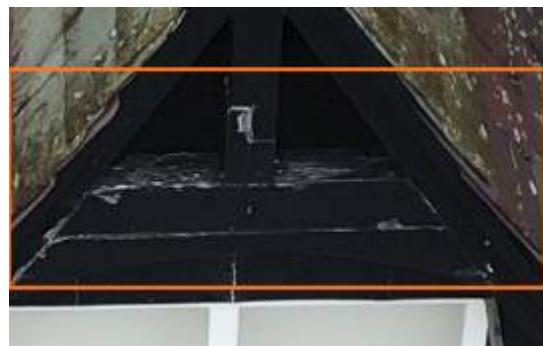
2673973 Severity: 2 Paint Coat Failed

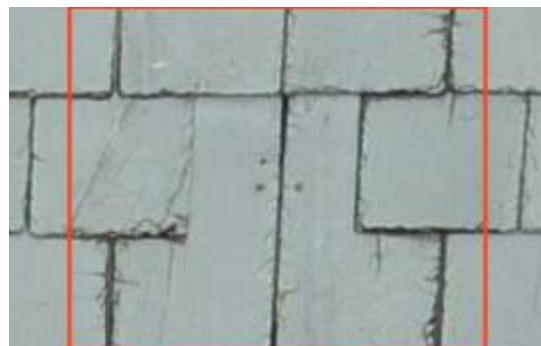
2674188 Severity: 4 Missing Slate

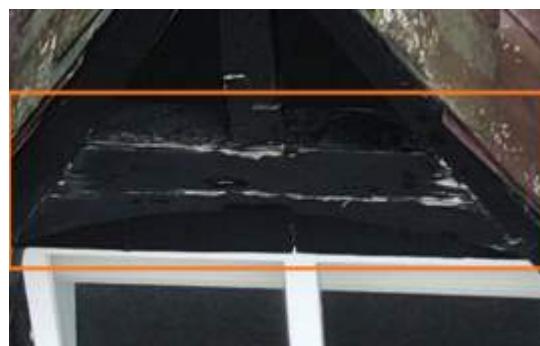
2674247 Severity: 2 Paint Coat Failed

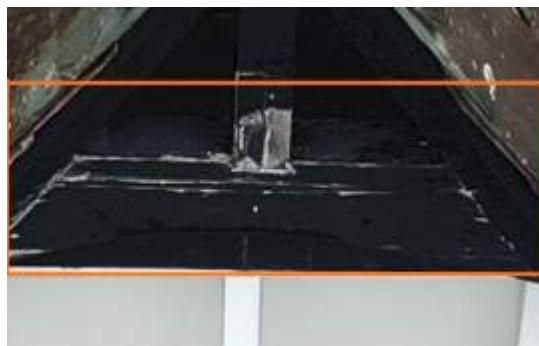
2674250 Severity: 2 Paint Coat Failed

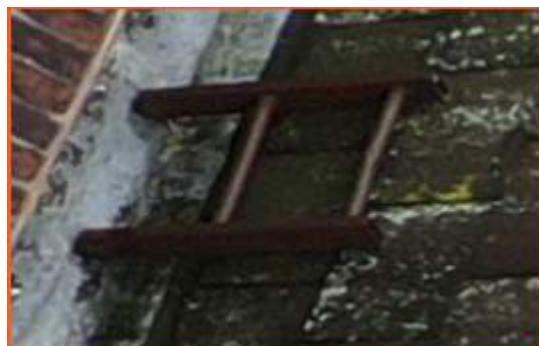
2674312 Severity: 3 Loose Object

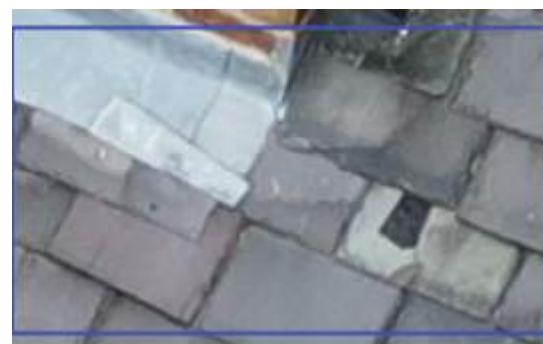
2674626 Severity: 0 Historic Repair

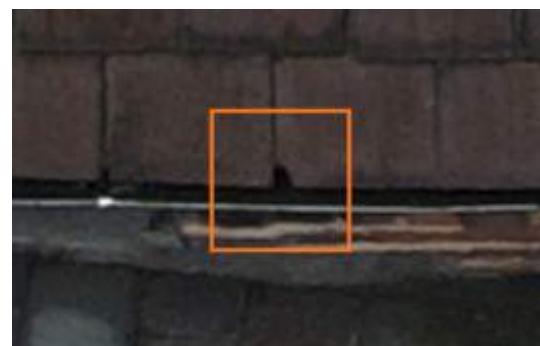
2674640 Severity: 2 Damaged Slate

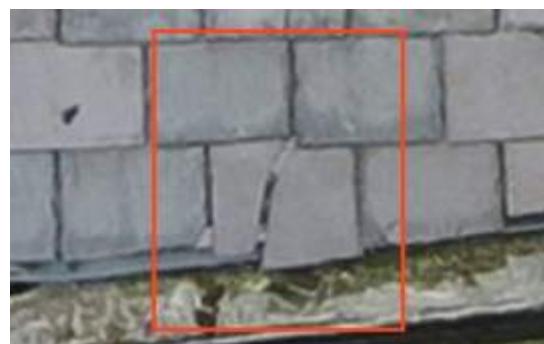
2674730 Severity: 4 Damaged Slate

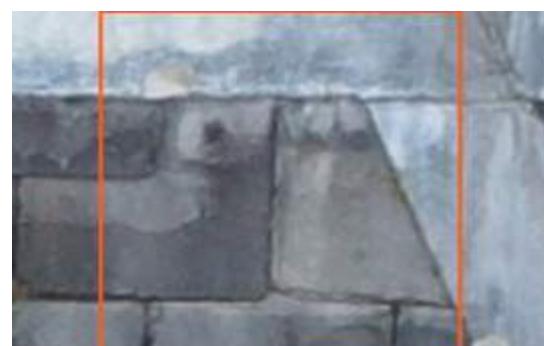
2674749 Severity: 3 Missing Slate

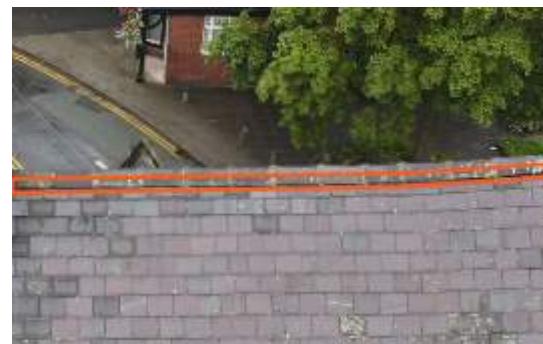
2674772 Severity: 3 Missing Mortar to Ridge

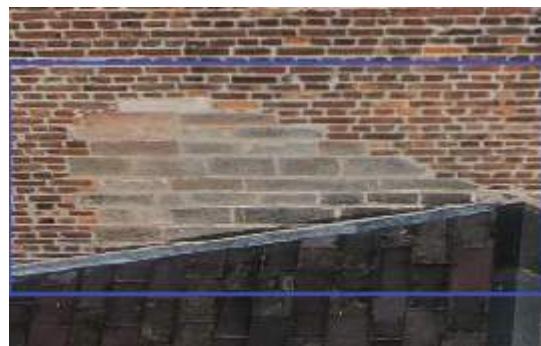
2674791 Severity: 0 Historic Repair

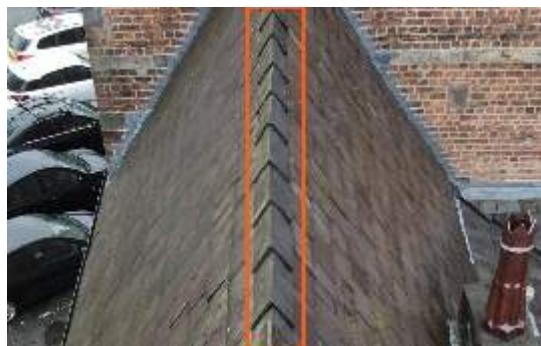
2674815 Severity: 3 Missing Mortar to Ridge

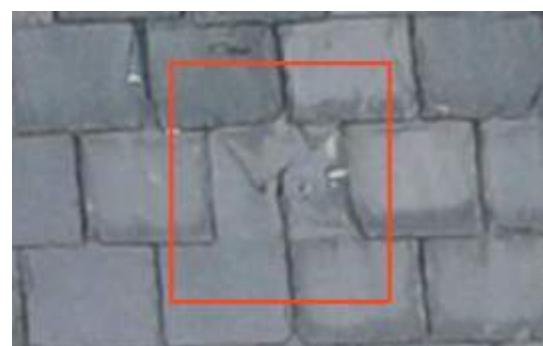
2674842 Severity: 4 Damaged Slate

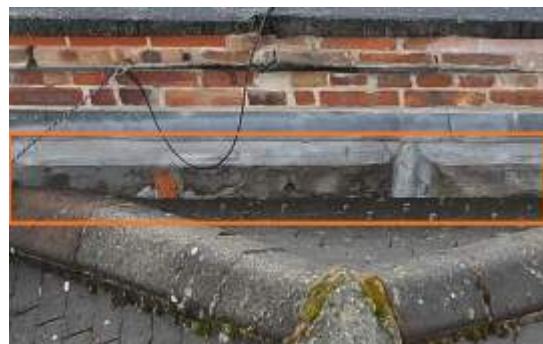
2675691 Severity: 2 Loose Object

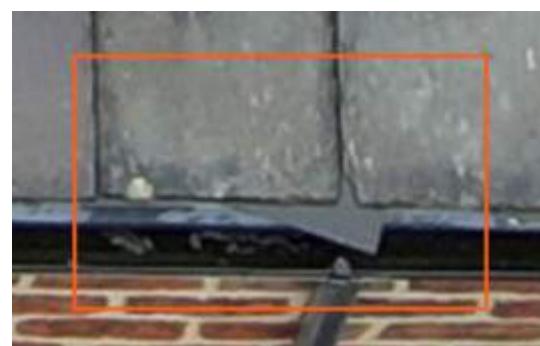
2675798 Severity: 3 Slipped Slate

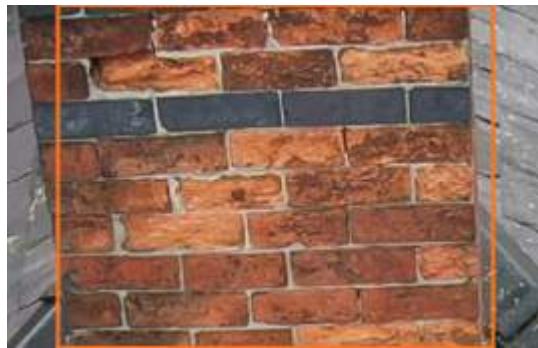
2675824 Severity: 2 Spalled Brick

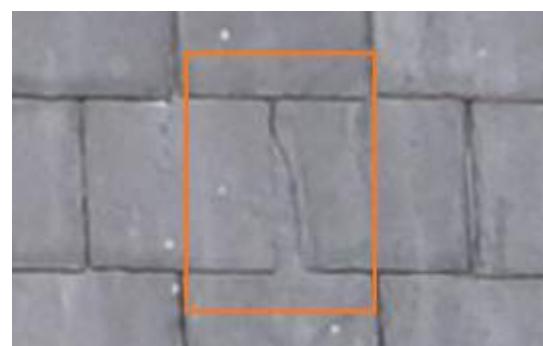
2675837 Severity: 2 Damaged Slate

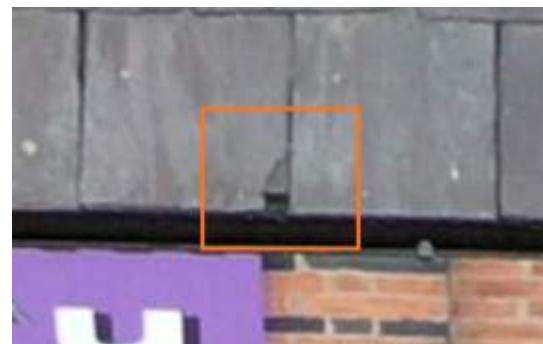
2675841 Severity: 2 Damaged Slate

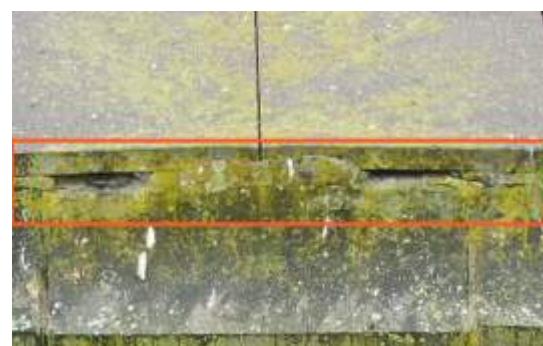
2675859 Severity: 3 Missing Mortar

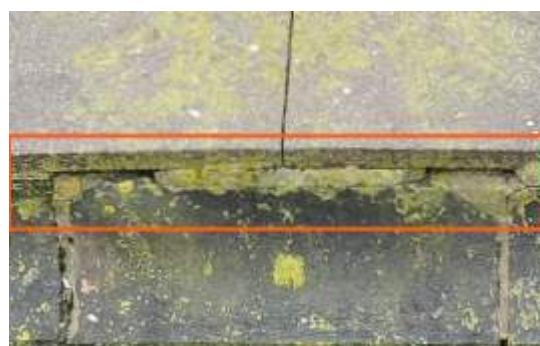
2675875 Severity: 3 Missing Mortar

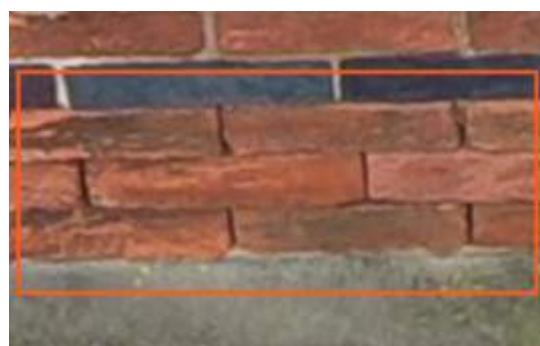
2675886 Severity: 3 Missing Mortar

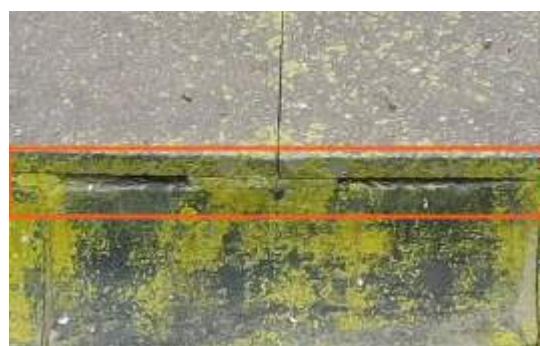
2675891 Severity: 3 Missing Mortar

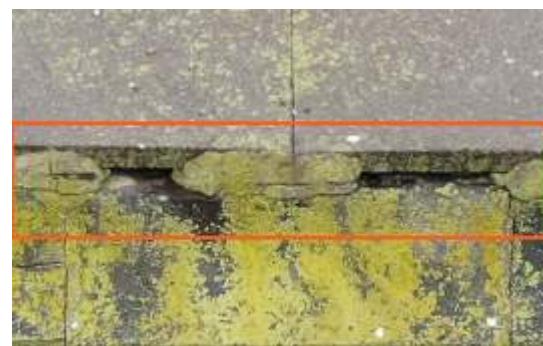
2675895 Severity: 3 Missing Mortar
