## **CONGLETON TOWN COUNCIL**

## **COMMITTEE REPORTS AND UPDATES**

COMMITTEE:	Town Hall, Assets and Services Committee Meeting			
MEETING DATE AND TIME	12 <sup>th</sup> January 2023	LOCATION	Congleton Town Hall	
REPORT FROM	Town Hall Manager – Mark Worthington			
AGENDA ITEM REPORT TITLE	Agenda Item 9: Paddling Pool Soft Play Surface			
Background	The pathway around the paddling pool edge and leading to the toilet facilities is made from a wet pour rubber, anti-slip surface. Wet pour is an impact absorbing rubber crumb safety surface. The rubber granules are mixed with a polyurethane resin and laid in the desired colour to a thickness of, in this case, 15mm.  The existing wet pour pathway was installed in 2017 and is beyond any agreed guarantee. The pathway is started to show signs of wear including a split in the wet pour surface which continues around the circumference of the paddling pool pathway. On inspection in December the pathway surface had deteriorated further and will continue to do so throughout the Winter months.

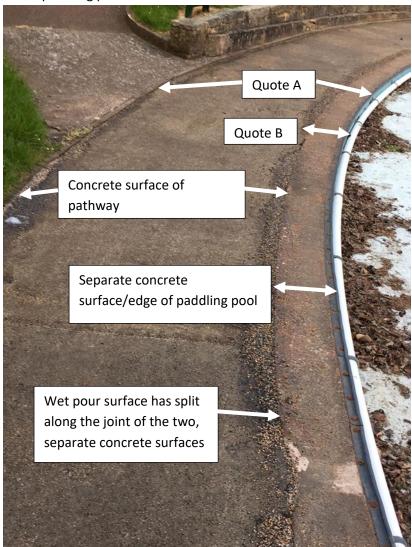
Picture below, taken during the 2017 install, shows the surface of the pathway on which the wet pour surface will be poured. The picture also indicates why the damage to the path surface (reflective cracking) is located in the same place around the circumference of the paddling pool.

Work will involve removing the existing 15mm wet pour surface and replacing with a 25mm wet pour surface. The surface will be laid in two stages, a 10mm subbase of wet pour, followed by a 15mm top layer of wet pour. This will prevent the top layer from

splitting in the same area as the existing wet pour surface. Regarding Quote B, each company add the caveat that with this type of repair, there is always a chance the joi could split between the new and old wet pour surfaces and/or along the same joint between the concrete surfaces.	
Decision Request	To receive the report and to agree for Company A to carry out work at the Paddling Pool to replace the existing wet pour surface as detailed in their quote.
