Trees for Congleton Site		
St John's Recreation Ground		
Title	Planting plan - south	Date
		06/11/21
Drawing Number	21-22/SJ/3	Scale
		1:750@A3
Drawn By	RB

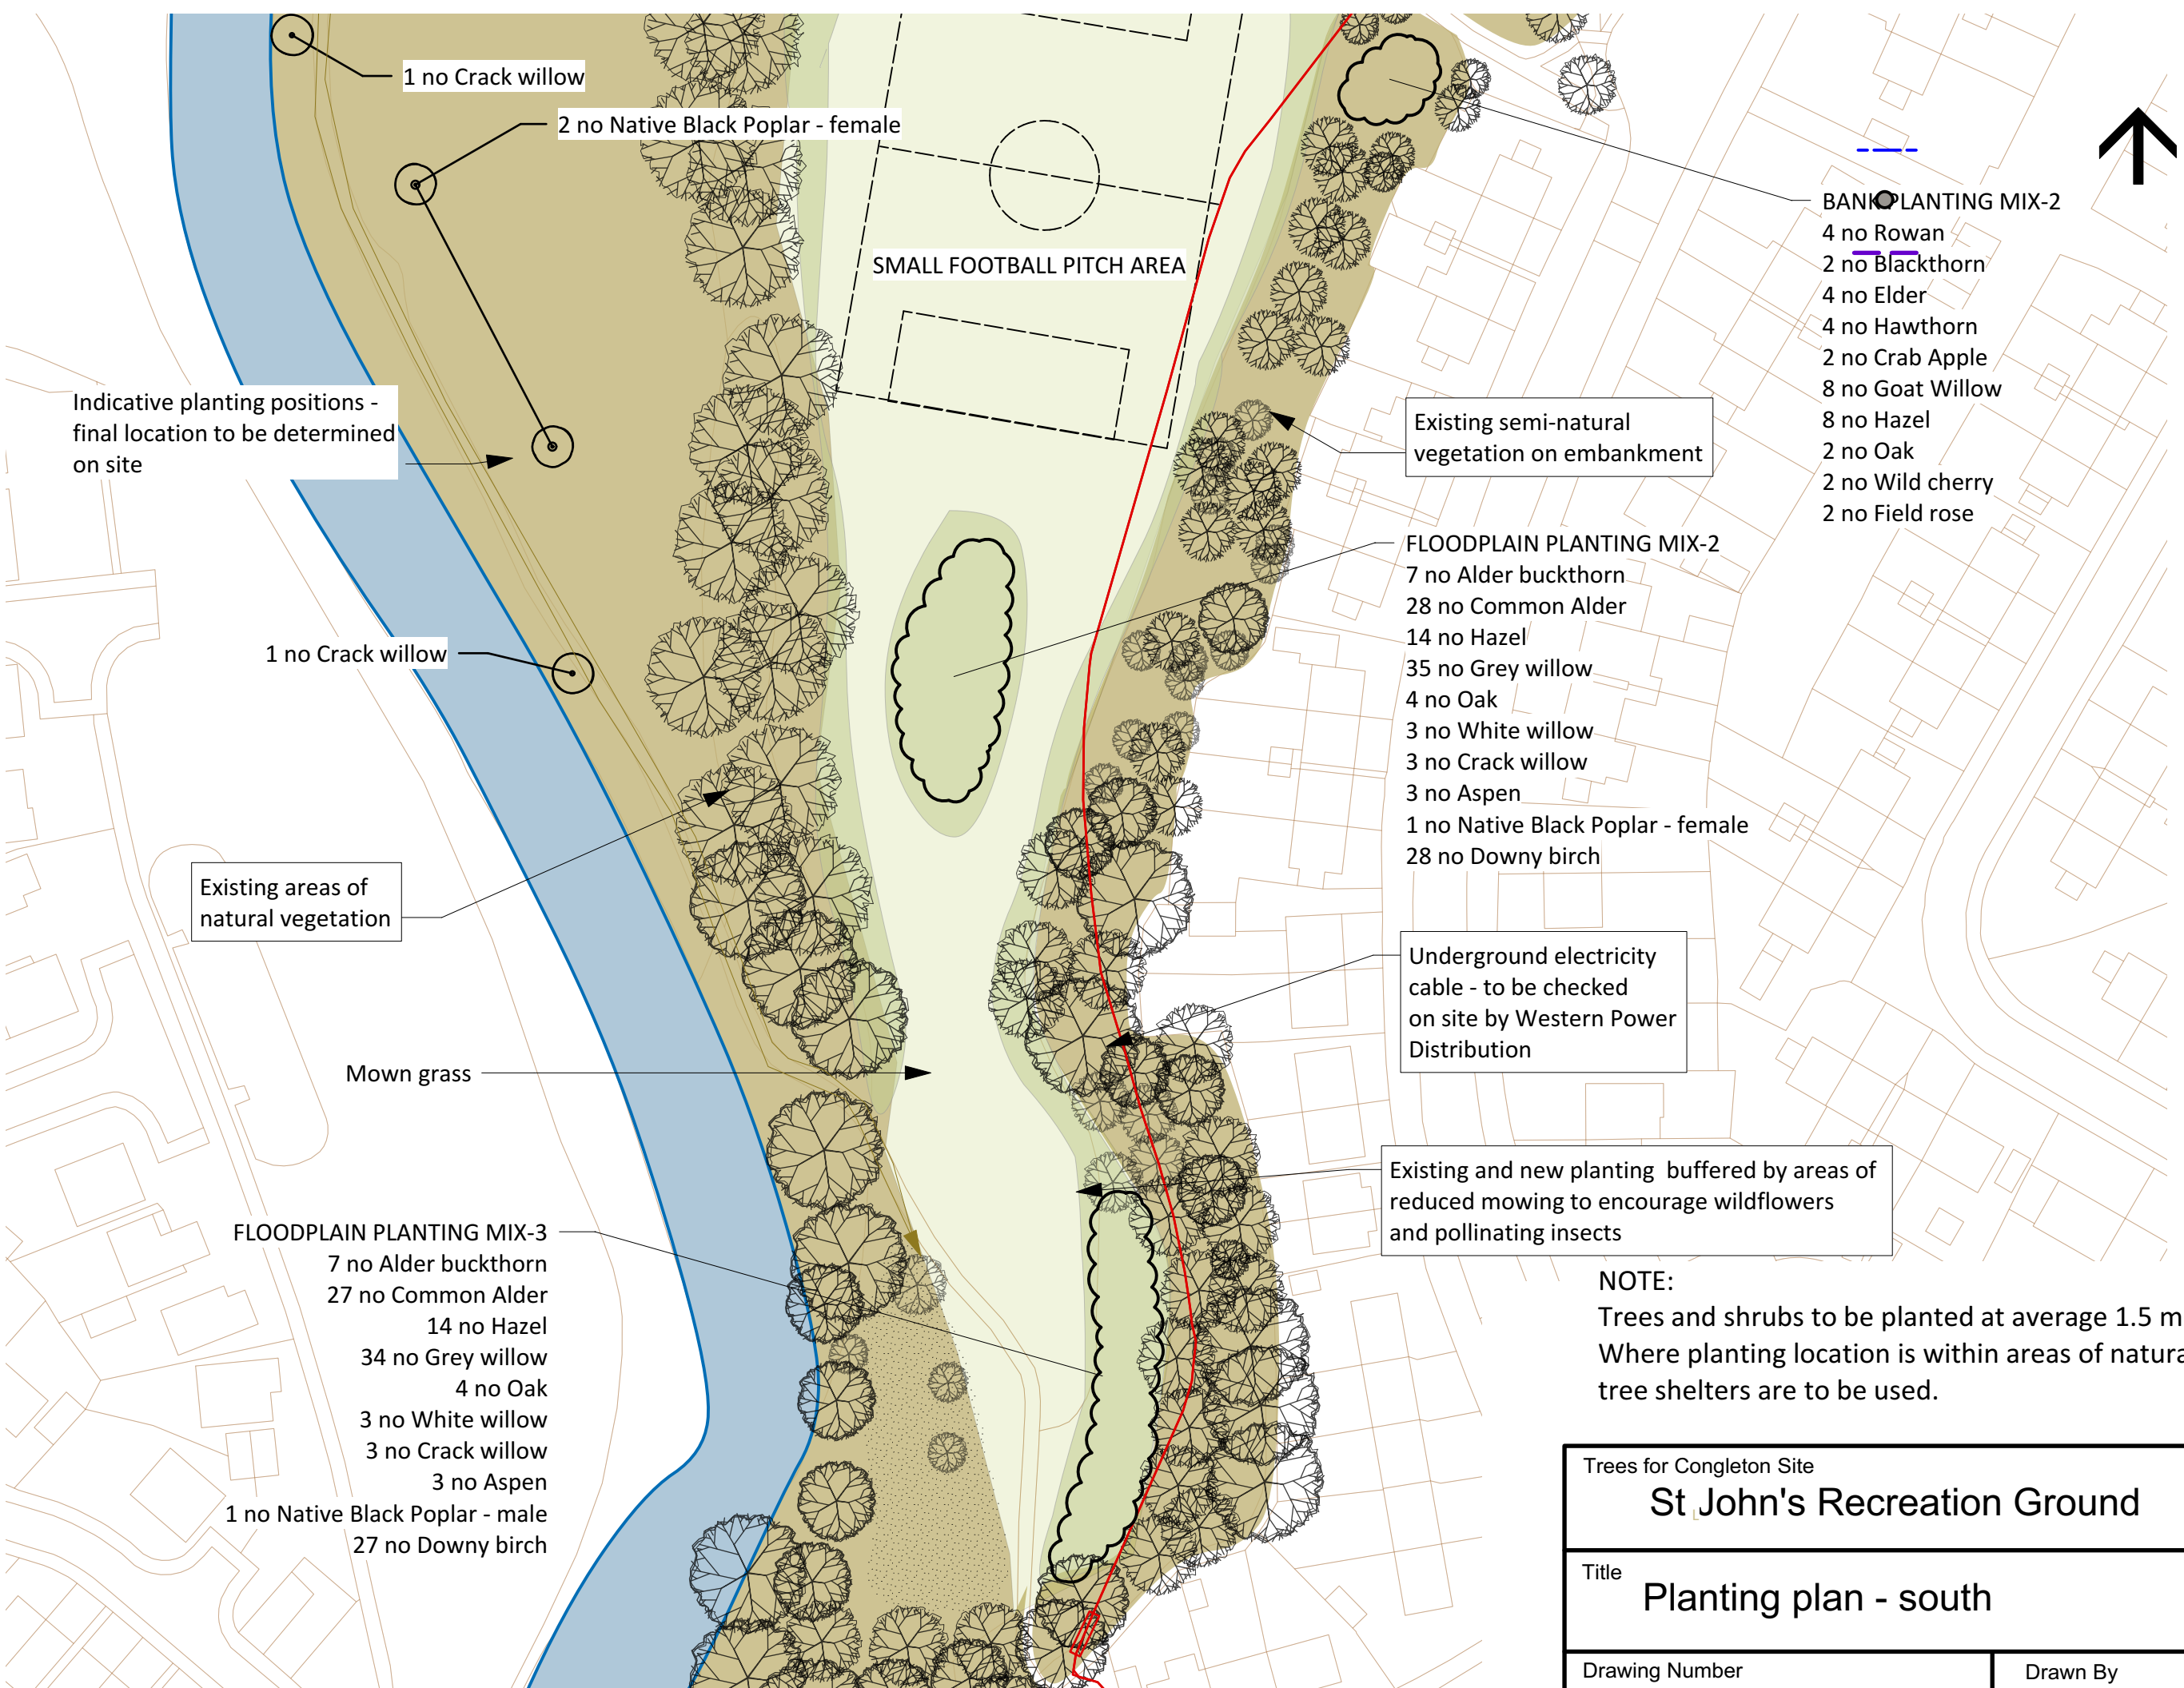
BANK PLANTING MIX-2

- 4 no Rowan
- 2 no Blackthorn
- 4 no Elder
- 4 no Hawthorn
- 2 no Crab Apple
- 8 no Goat Willow
- 8 no Hazel
- 2 no Oak
- 2 no Wild cherry
- 2 no Field rose

Indicative planting positions - final location to be determined on site

FLOODPLAIN PLANTING MIX-2

- 7 no Alder buckthorn
- 28 no Common Alder
- 14 no Hazel
- 35 no Grey willow
- 4 no Oak
- 3 no White willow
- 3 no Crack willow
- 3 no Aspen
- 1 no Native Black Poplar - female
- 28 no Downy birch

Underground electricity cable - to be checked on site by Western Power Distribution

Existing and new planting buffered by areas of reduced mowing to encourage wildflowers and pollinating insects

FLOODPLAIN PLANTING MIX-3

- 7 no Alder buckthorn
- 27 no Common Alder
- 14 no Hazel
- 34 no Grey willow
- 4 no Oak
- 3 no White willow
- 3 no Crack willow
- 3 no Aspen
- 1 no Native Black Poplar - male
- 27 no Downy birch

Trees and shrubs to be planted at average 1.5 m spacing
Where planting location is within areas of natural vegetation growth, tree shelters are to be used.
