Trees for Congleton Site
St John's Recreation Ground

Title **Planting plan - north** Date **06/11/21**

Drawing Number **21-22/SJ/2**

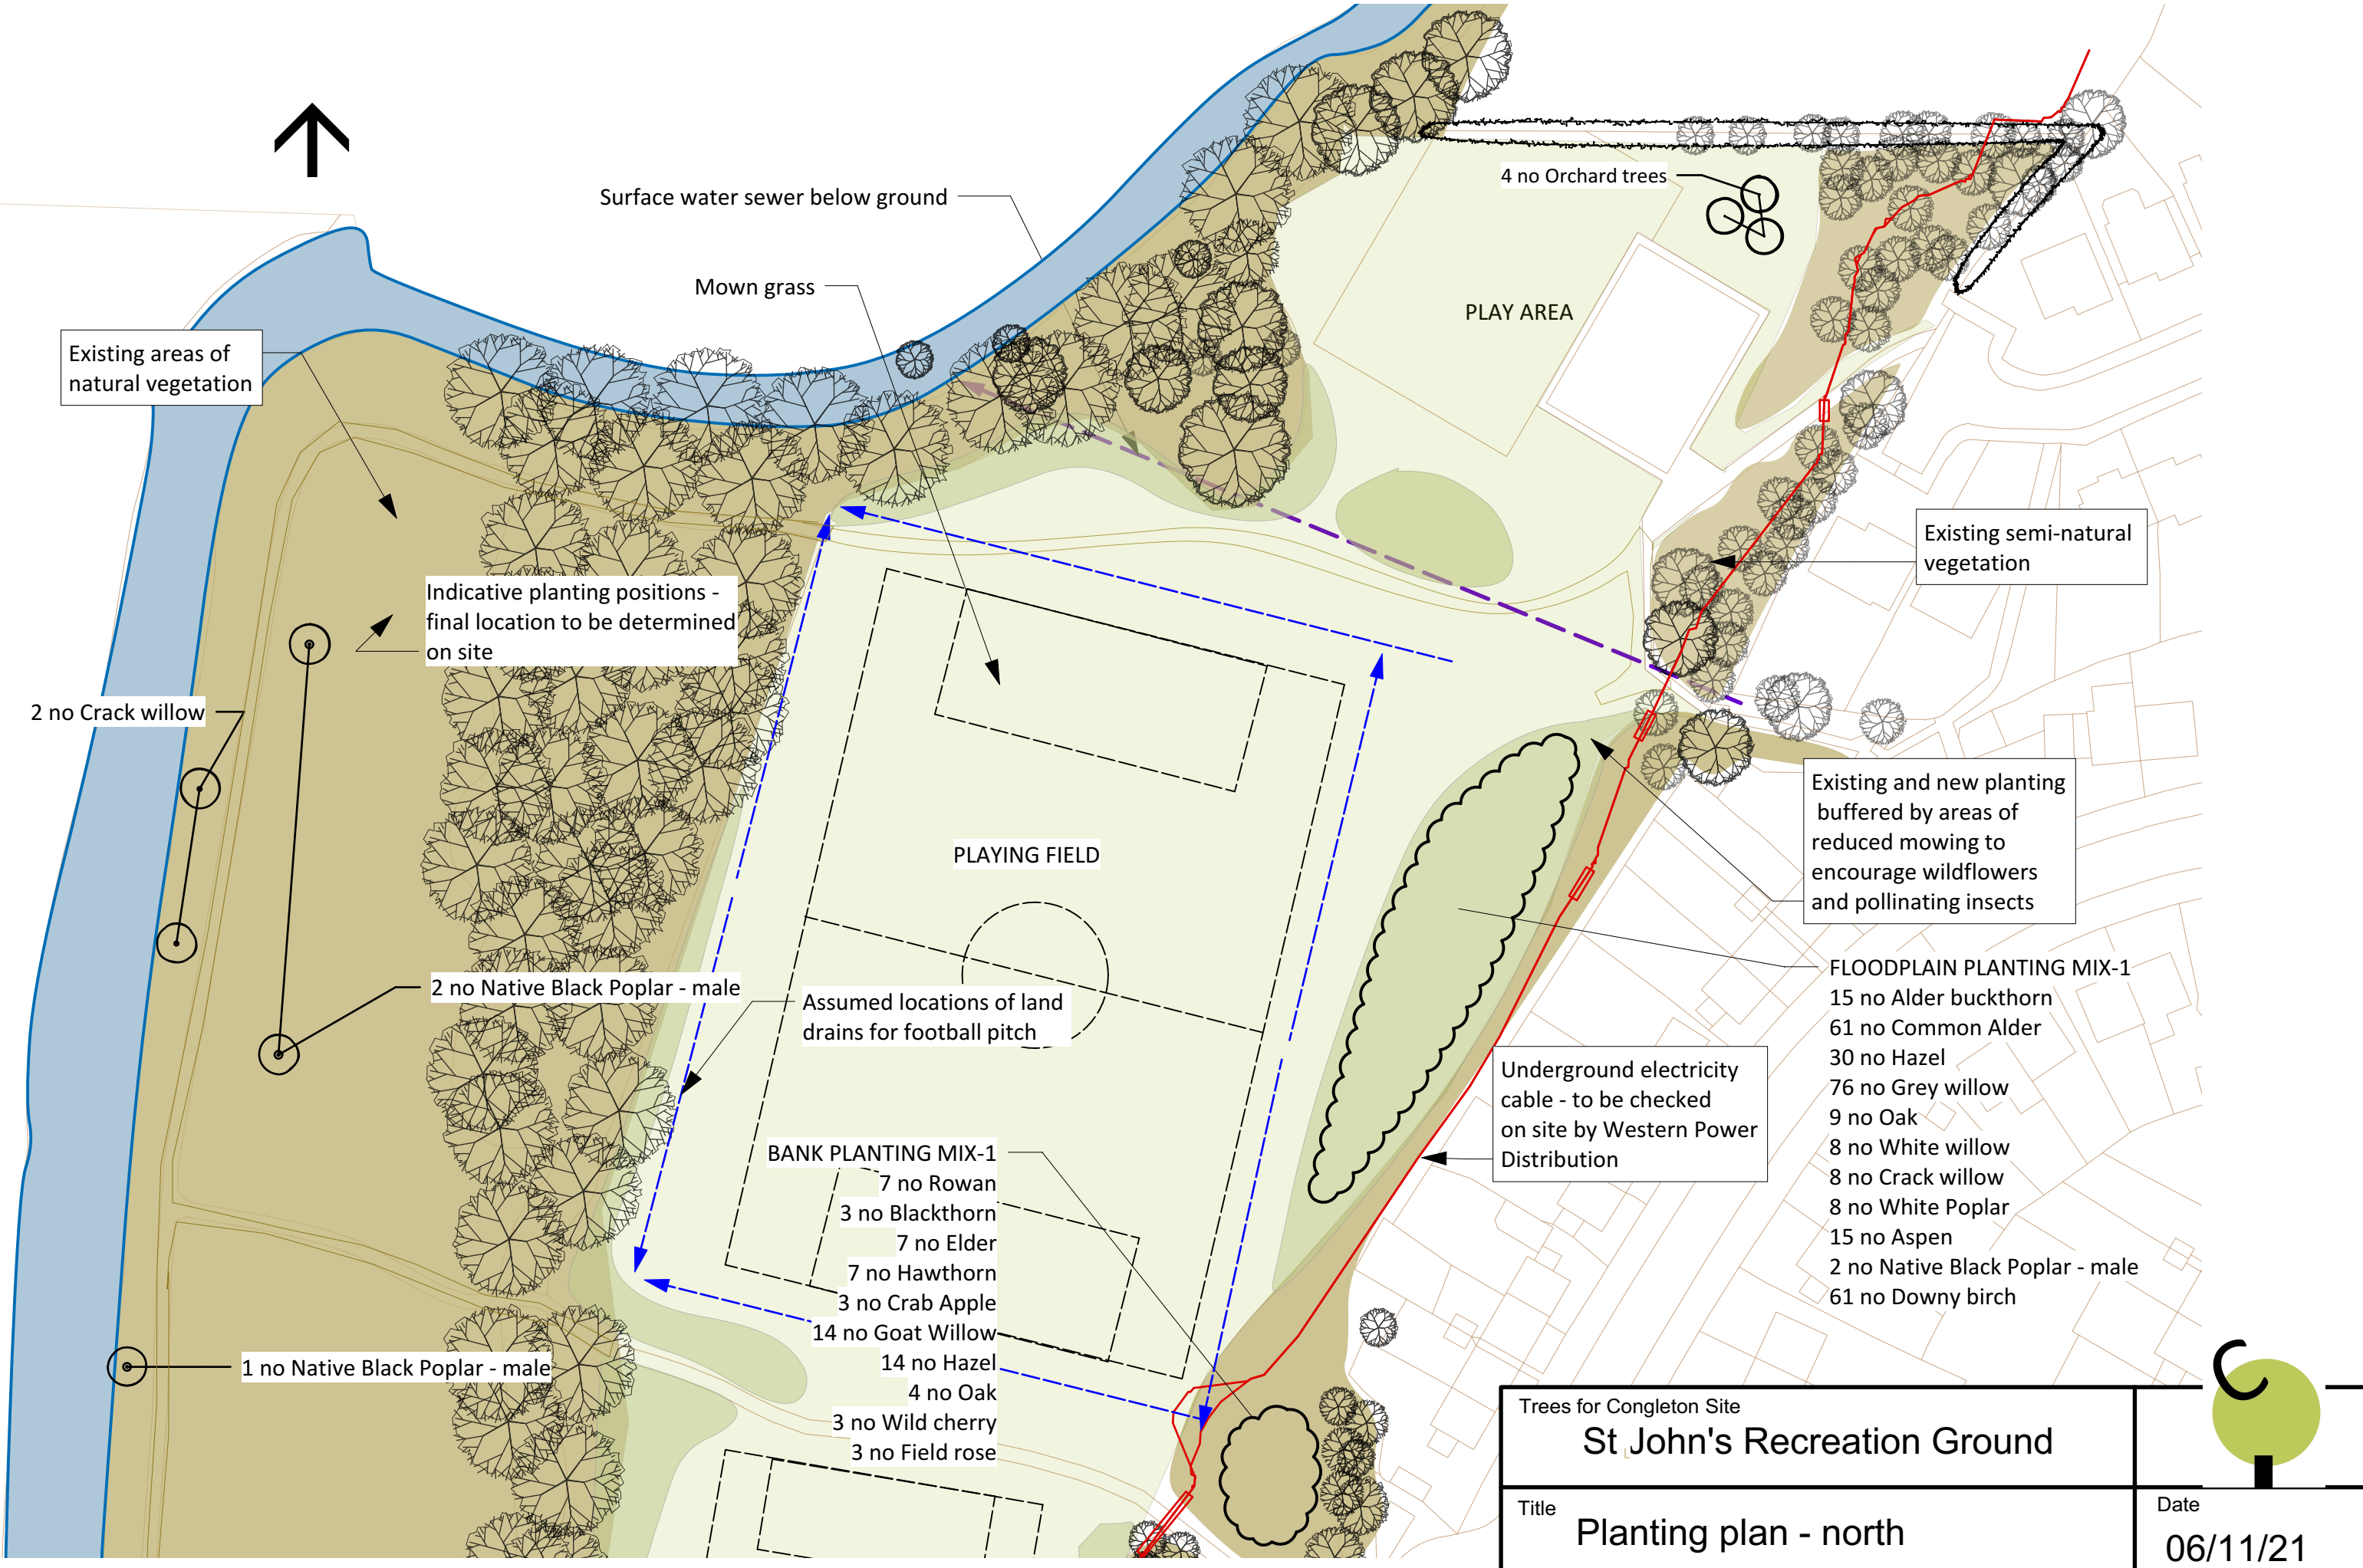
Indicative planting positions - final location to be determined on site

Existing and new planting buffered by areas of reduced mowing to encourage wildflowers and pollinating insects

FLOODPLAIN PLANTING MIX-1

Assumed locations of land drains for football pitch

Underground electricity cable - to be checked on site by Western Power Distribution

- 15 no Alder buckthorn
- 61 no Common Alder
- 30 no Hazel
- 76 no Grey willow
- 9 no Oak
- 8 no White willow
- 8 no Crack willow
- 8 no White Poplar
- 15 no Aspen
- 2 no Native Black Poplar - male
- 61 no Downy birch

BANK PLANTING MIX-1

- 7 no Rowan
- 3 no Blackthorn
- 7 no Elder
- 7 no Hawthorn
- 3 no Crab Apple
- 14 no Goat Willow
- 14 no Hazel
- 4 no Oak
- 3 no Wild cherry
- 3 no Field rose

NOTE: Trees and shrubs to be planted at average 1.5 m spacing
 Where planting location is within areas of natural vegetation growth, tree shelters are to be used.
