## CONGLETON TOWN COUNCIL

COMMITTEE:	Council		
MEETING DATE AND TIME	9 <sup>th</sup> February 2023	LOCATION	Congleton Town Hall
REPORT FROM	Town Hall Manager – Mark Worthington / Chief Officer		
AGENDA ITEM REPORT TITLE	Agenda Item 8 Paddling Pool Soft Play Surface		
Background	<p>This item was previously presented to the previously presented to the THAS committee on the 12th January 2023. The resolution from that meeting was as follows</p> <p><b>THAS/31/2223 Resolved to</b> receive the updates on matters relating to the paddling pool Soft play surface and noted comments for consideration with regards to:</p> <ul style="list-style-type: none"><li>• Different types of surfaces suitable for around paddling pool</li><li>• Checks to see the legality behind what type of surface is required</li></ul> <p>Furthermore to accept the report and delegate the authority to the Chief Officer and Town Hall Manager to make the decision on the type of surface suitable for the paddling pool up to a budget £13,125</p> <p><b>The report stated</b></p> <p>The pathway around the paddling pool edge and leading to the toilet facilities is made from a wet pour rubber, anti-slip surface. Wet pour is an impac

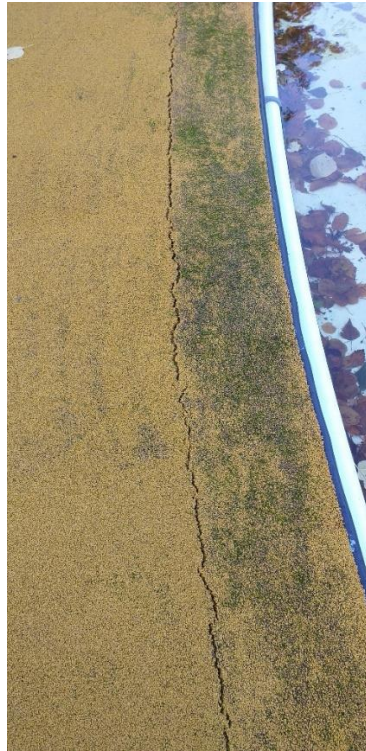
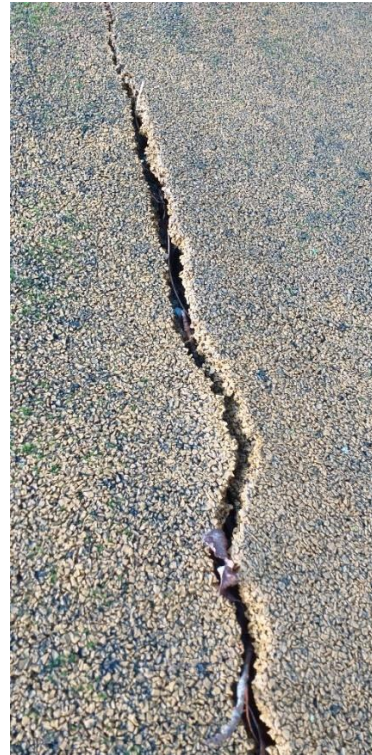
Three companies have been contacted to provide quotes to replace, or partially replace, the damaged wet pour surface around the paddling pool edge and leading to the toilet facilities. Pictures below highlight the issue where the wet pour surface needs to be replaced.

For Quote 1, work will involve removing the existing 15mm wet pour surface and replacing with a 25mm wet pour surface. The surface will be laid in two stages, a 10mm subbase of wet pour, followed by a 15mm top layer of wet pour. This will help to avoid the top layer from splitting in the same area as the existing wet pour surface. Quote 1 works will be provided with a one year guarantee. Extended guarantees are available, however there are caveats on this, one being to approve the sub base. The existing sub base would not be eligible for an extended guarantee due to the underlying issues with the joint around the subbase.

<b>Decision Request</b>	<p>The proposal is for the Town Council to proceed with the Company A Quote 1 to carry out work at the Paddling Pool to replace the existing wet pour surface at a cost of £13,125 plus VAT</p>

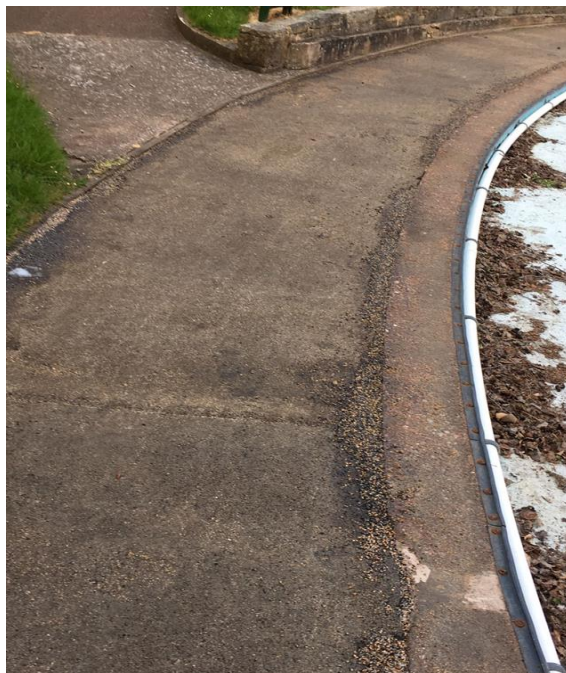
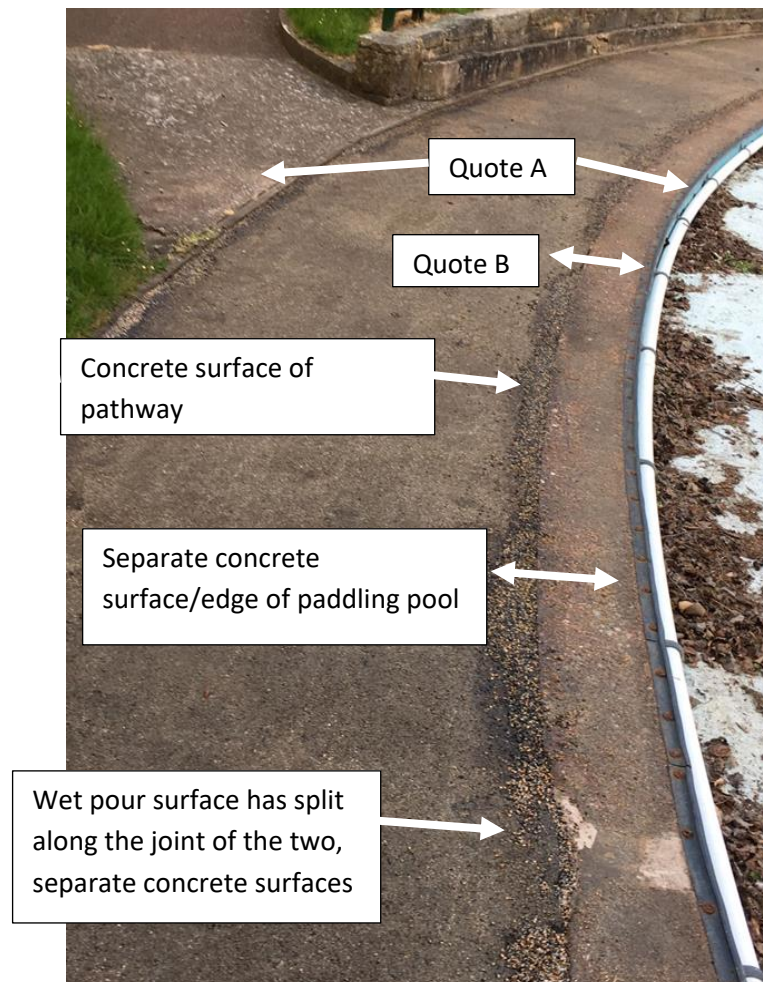
Picture below, taken during the 2017 install, shows the surface of the pathway on which the wet pour surface will be poured. The picture also indicates why the damage to the path surface (reflective cracking) is located in the same place around the circumference of the paddling pool.
