## **CONGLETON TOWN COUNCIL**

| <b>REPORT FROM</b> | <b>Town Hall Manager – Mark Worthington</b> | | |
| <b>REPORT TITLE</b> | <b>Roof Repairs Drone Survey (i)</b> | | |

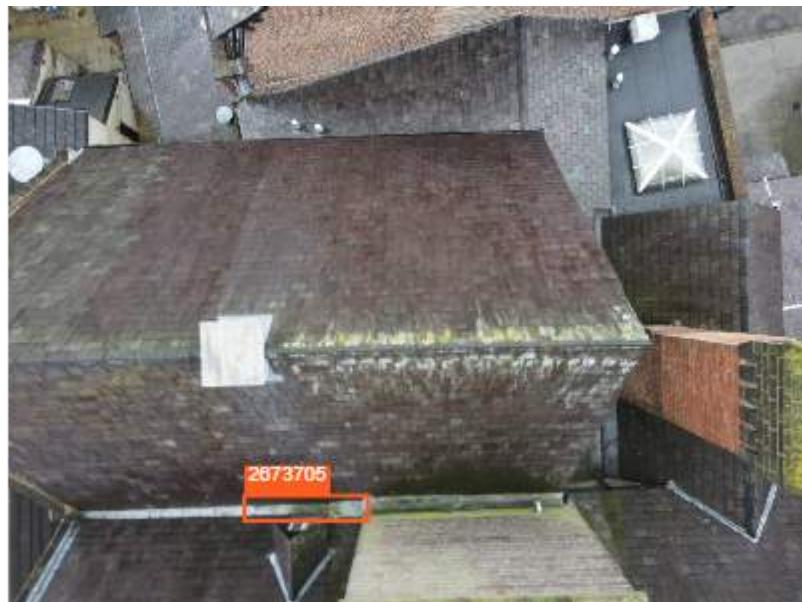
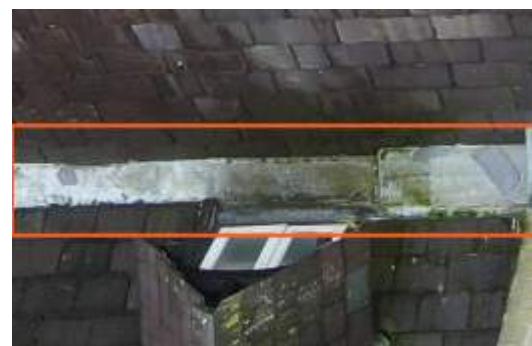
2673705 Severity: 3 Loose Object

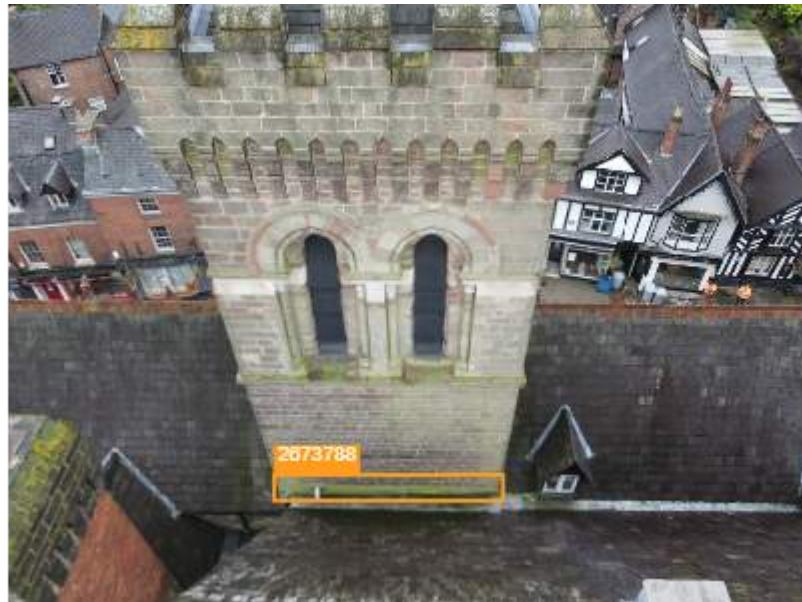
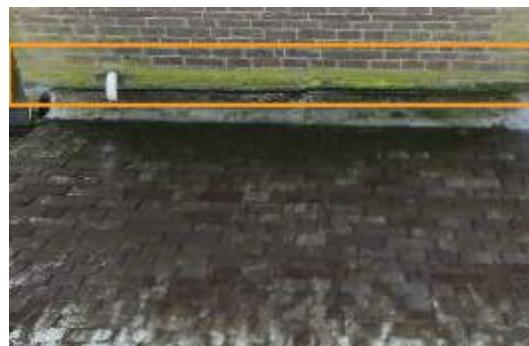
2673788 Severity: 1 Algae

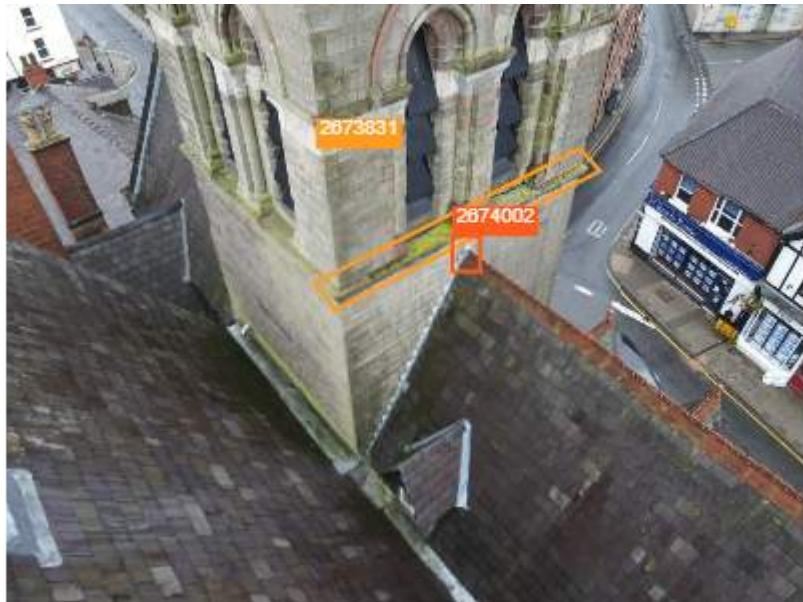
2673831 Severity: 1 Lichen Build Up

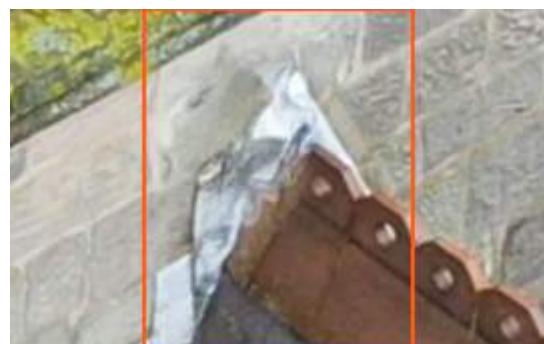
2674002 Severity: 3 Flashing

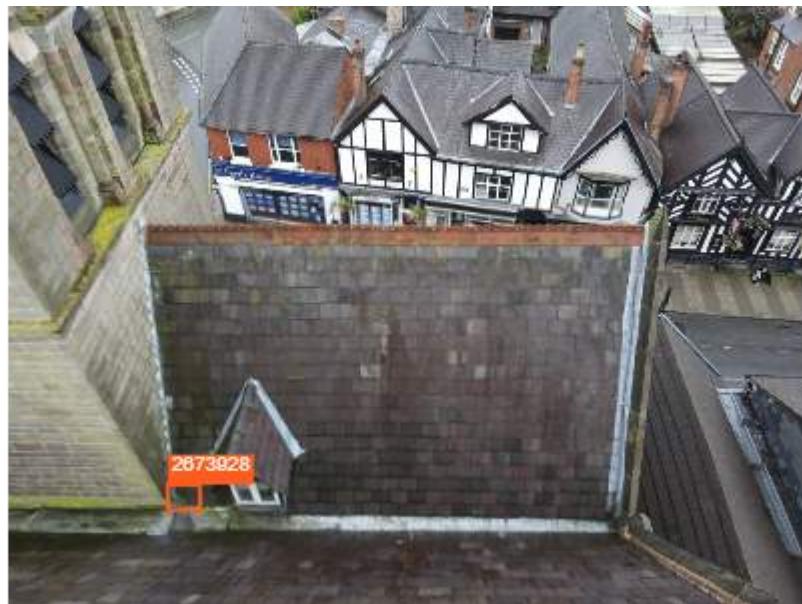
2673928 Severity: 3 Damaged Slate

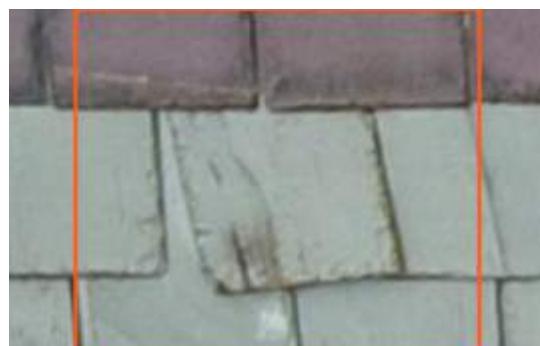
2673946 Severity: 3 Slipped Slate

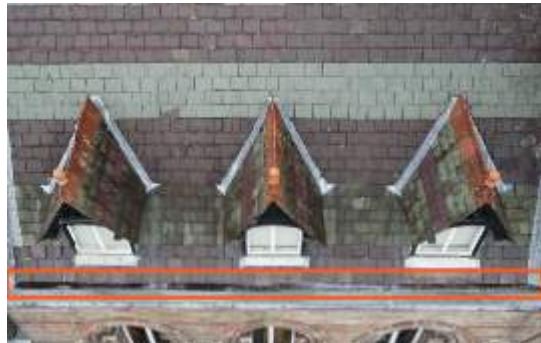
2674206 Severity: 3 Minor Debris in Gutter

We recommend all gutters and outlets are cleared as there is evidence of minor and significant debris within them as annotated.

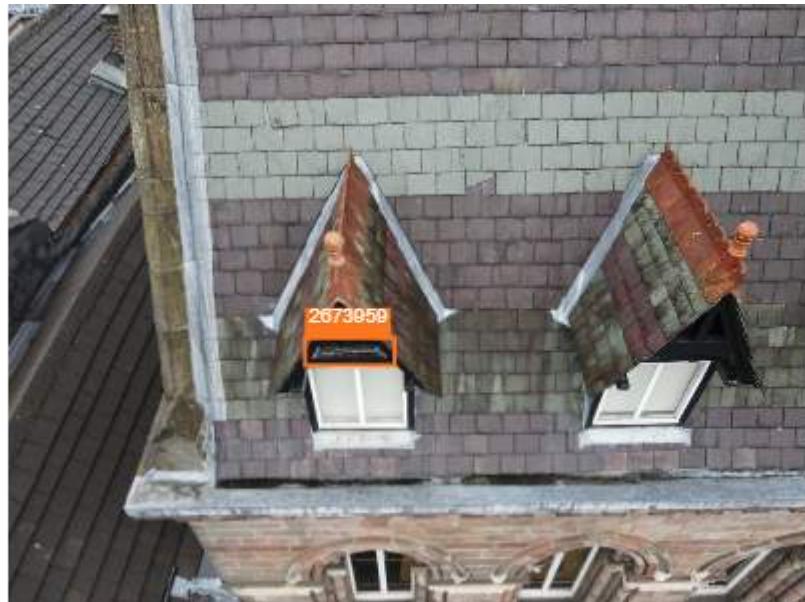
2673959 Severity: 2 Paint Coat Failed

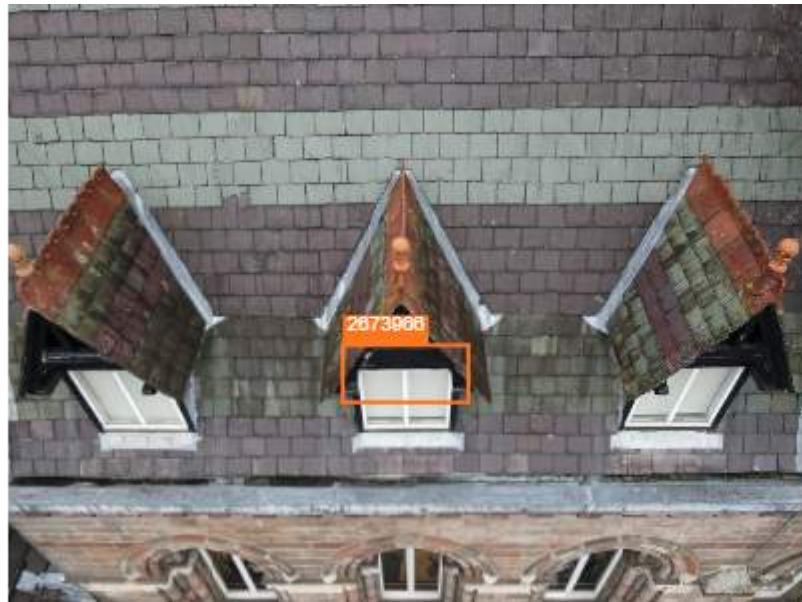
2673966 Severity: 2 Paint Coat Failed

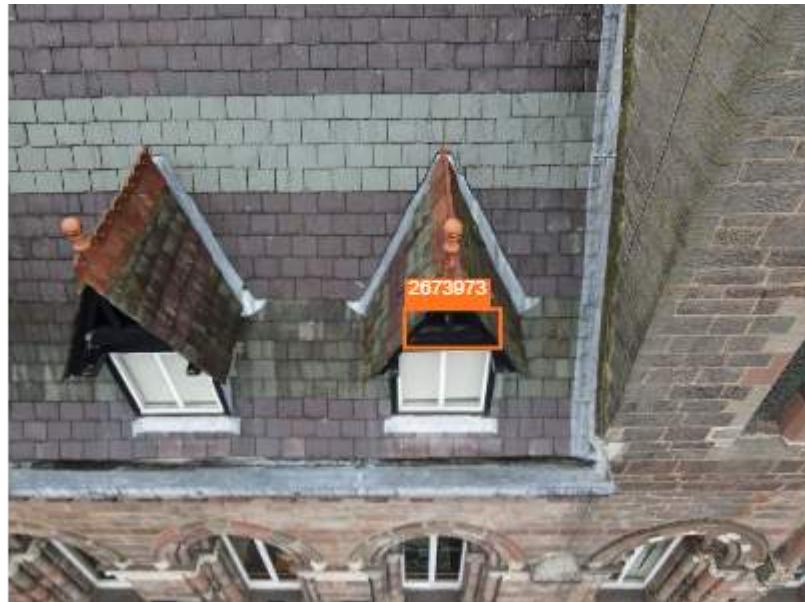
2673973 Severity: 2 Paint Coat Failed

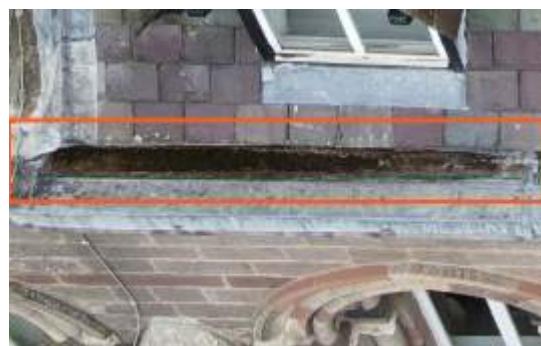
2674210 Severity: 3 Minor Debris in Gutter

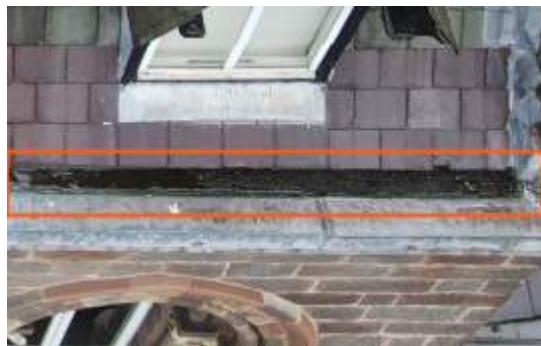
2674214 Severity: 3 Minor Debris in Gutter

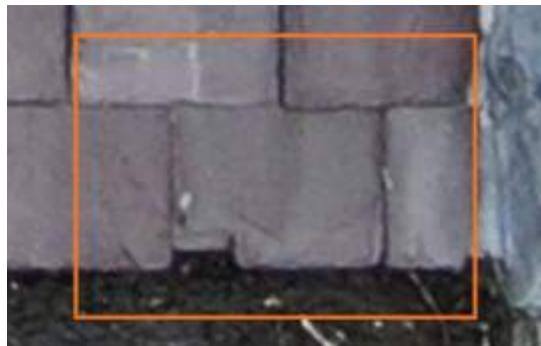
2674217 Severity: 2 Damaged Slate

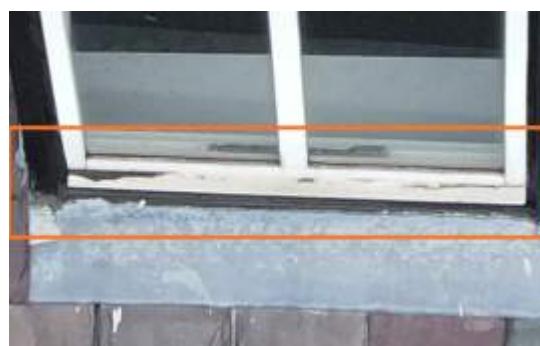
2674248 Severity: 2 Paint Coat Failed

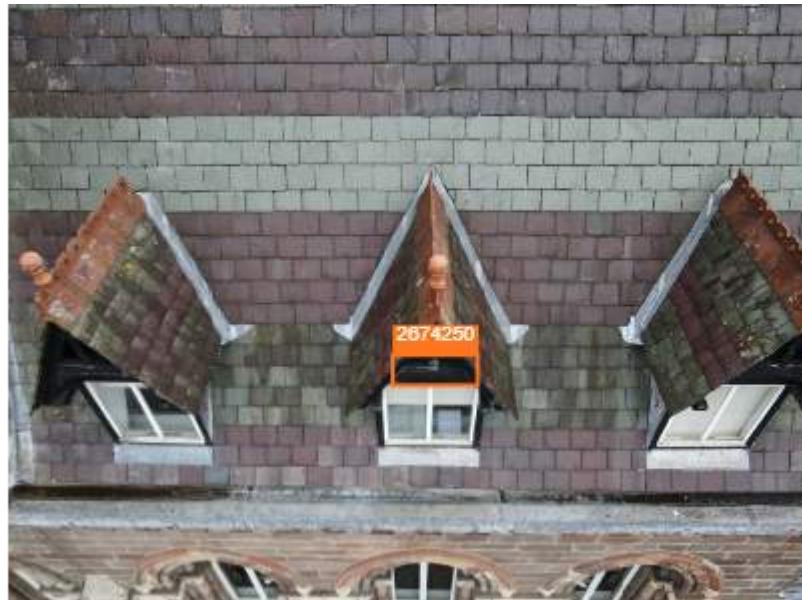
2674250 Severity: 2 Paint Coat Failed

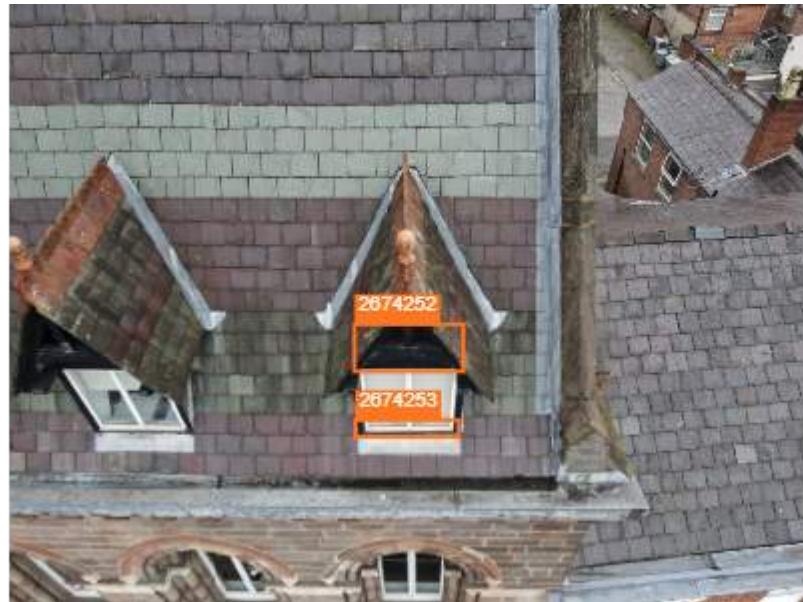
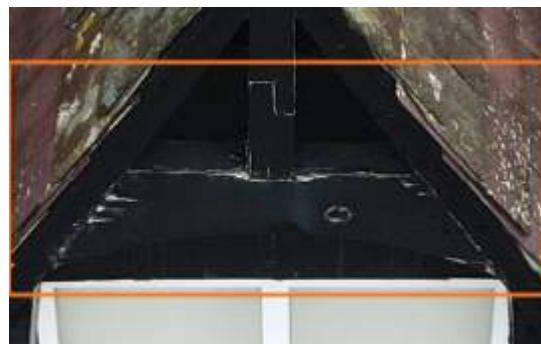
2674252 Severity: 2 Paint Coat Failed

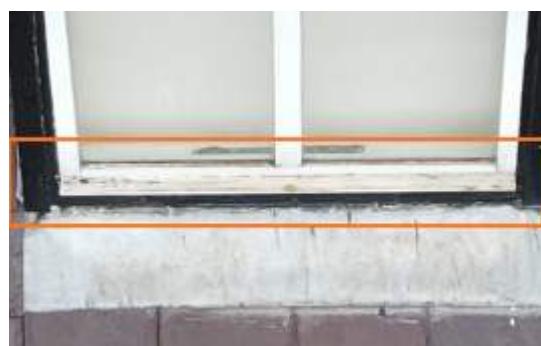
2674253 Severity: 2 Paint Coat Failed

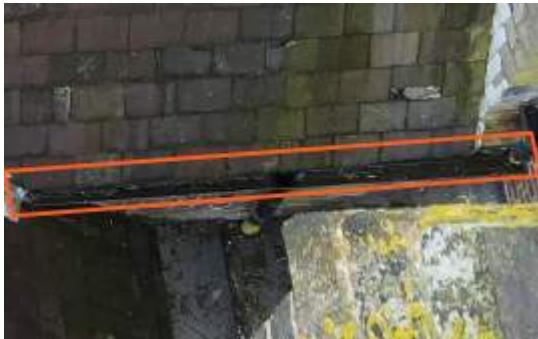
2674303 Severity: 3 Minor Debris in Gutter

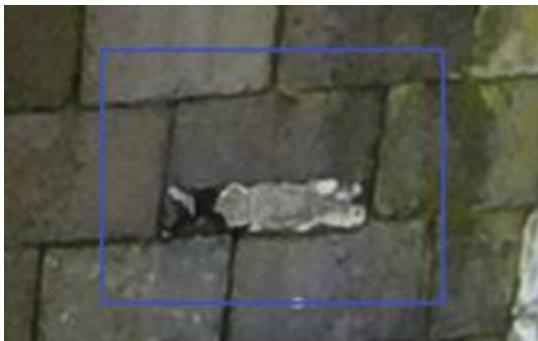
2674306 Severity: 0 Further Clarification Needed

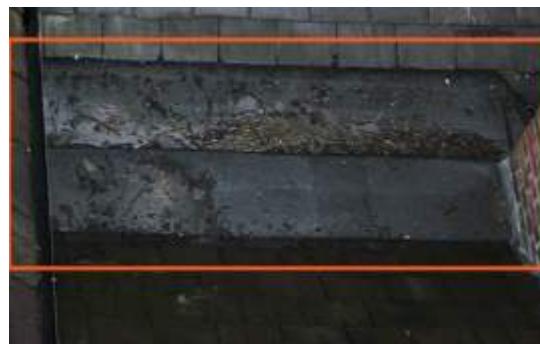
2674309 Severity: 3 Minor Debris in Gutter

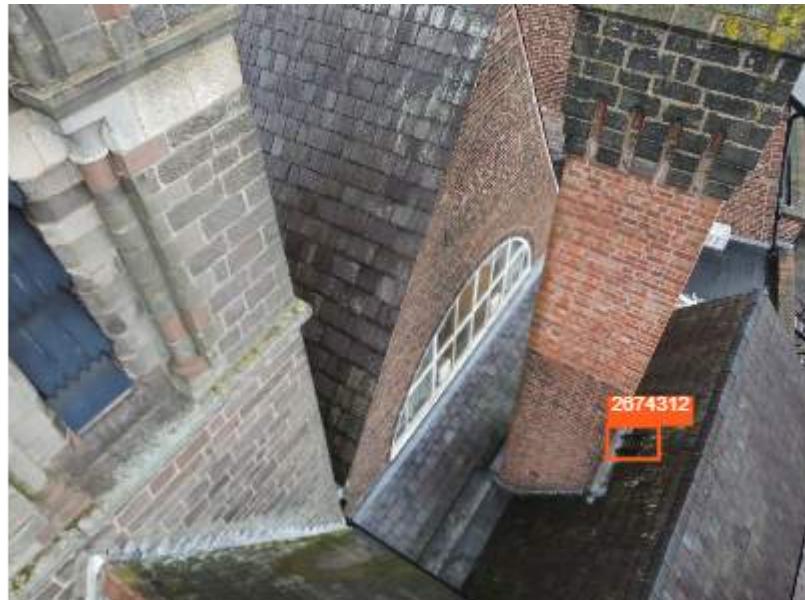
2674312 Severity: 3 Loose Object

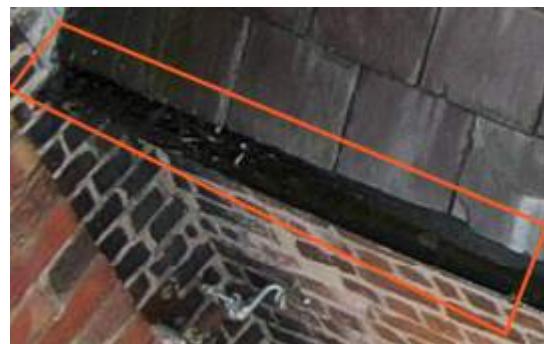
2674327 Severity: 3 Minor Debris in Gutter

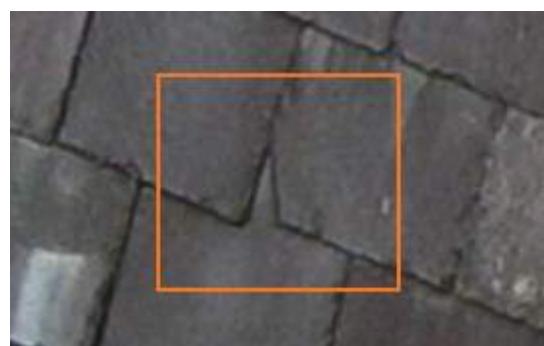
2674328 Severity: 2 Damaged Slate

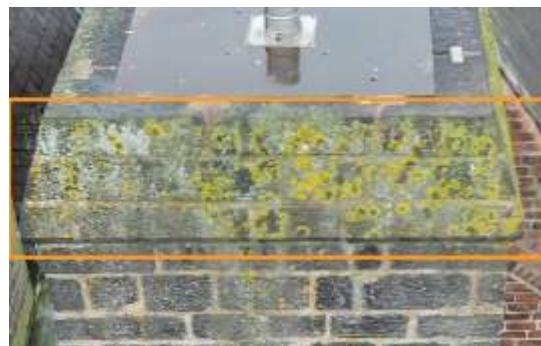
2674334 Severity: 1 Lichen Build Up

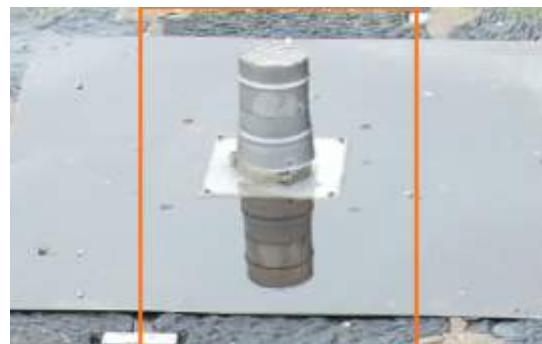
2674335 Severity: 2 Evidence of Standing Water

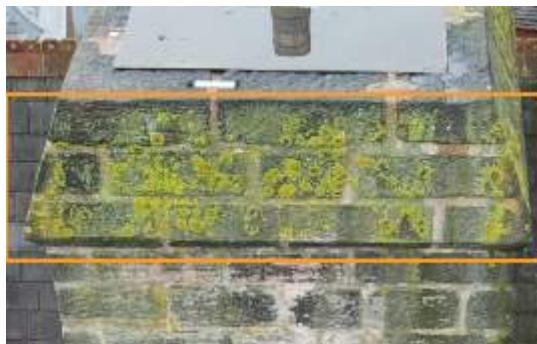
2674537 Severity: 1 Lichen Build Up

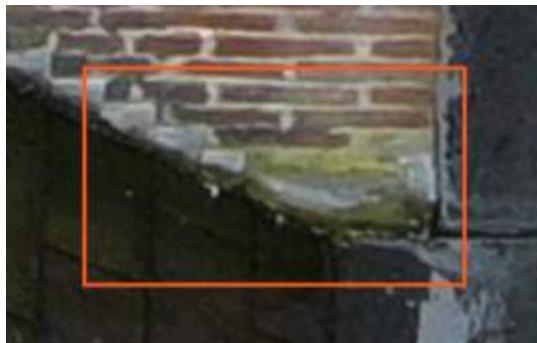
2674554 Severity: 3 Flashing

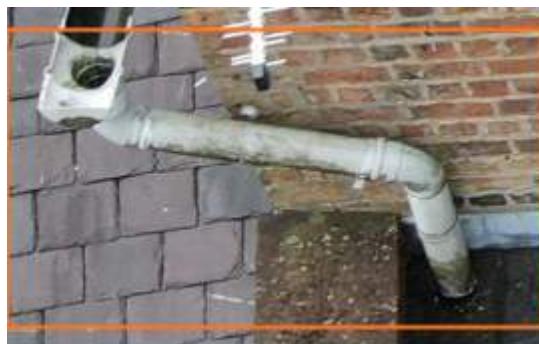
2674582 Severity: 2 Downpipe

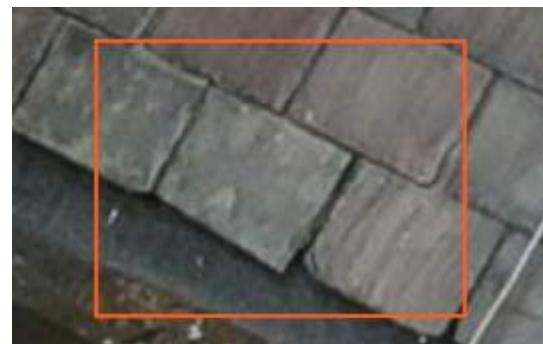
2674588 Severity: 3 Slipped Slate

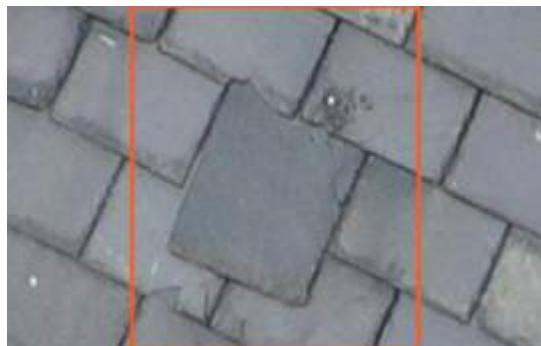
2674632 Severity: 3 Slipped Slate

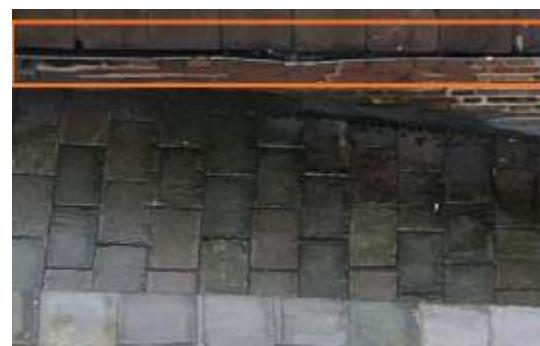
2674642 Severity: 2 Gutter Deformed

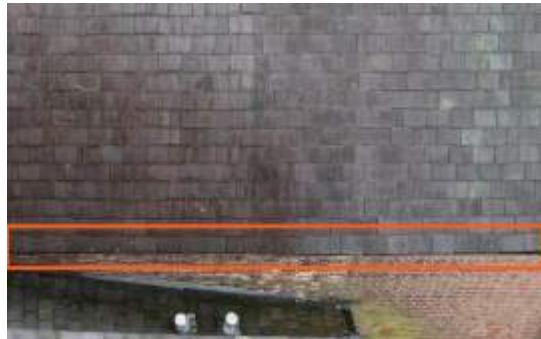
2674643 Severity: 3 Guttering

Gutter appears set back from edge of slate. Ensure water will collected in gutter without overspill.

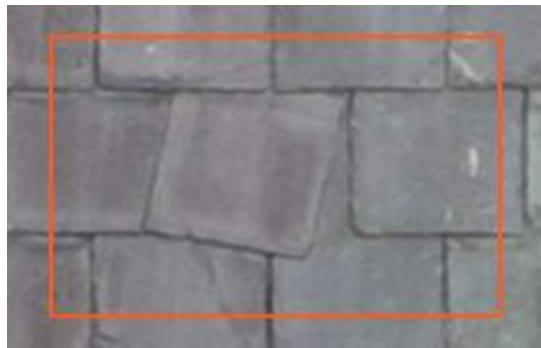
2674645 Severity: 3 Slipped Slate

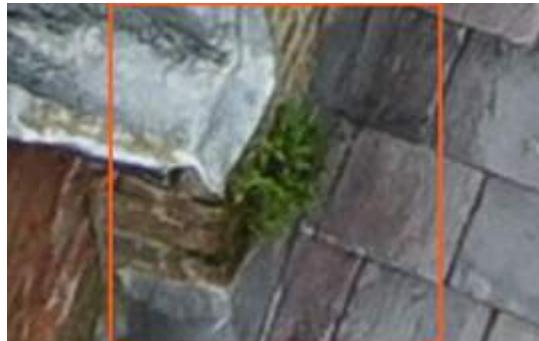
2674721 Severity: 3 Vegetation Growth

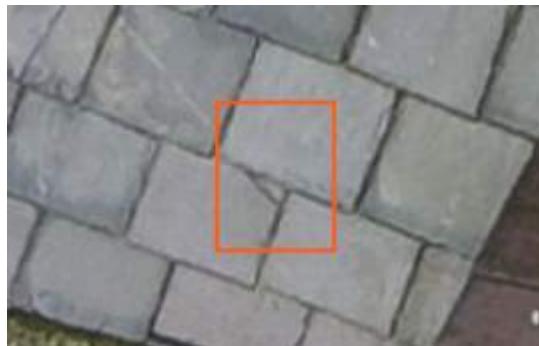
2674732 Severity: 3 Damaged Slate

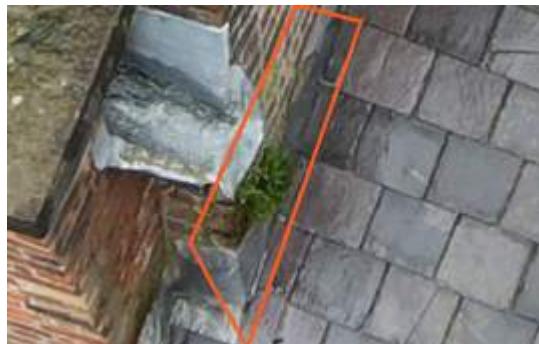
2674733 Severity: 3 Missing Flashing

Ensure flashing is not missing.

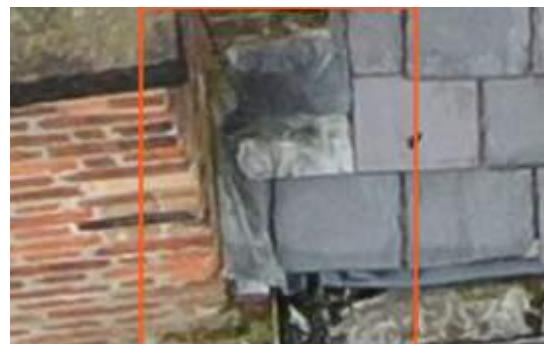
2674729 Severity: 3 Flashing

Further inspection recommended to ensure flashing is adequate.  
Lead replacement is not advised if this has been used.

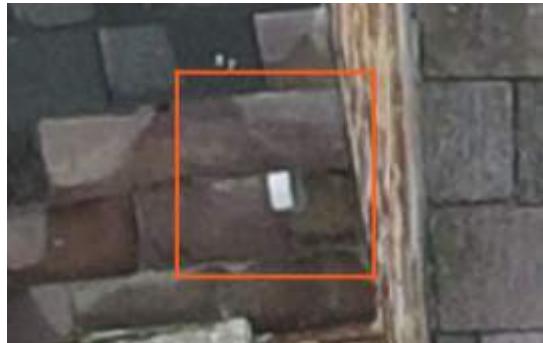
2674737 Severity: 3 Slate

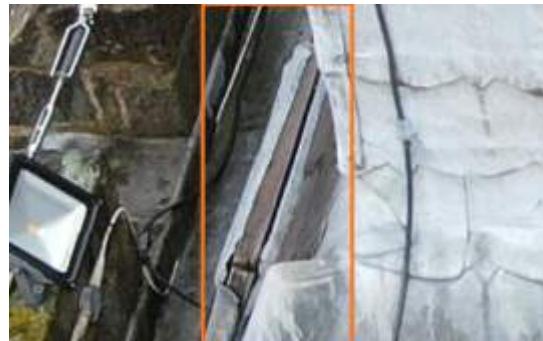
2674747 Severity: 2 Minor Timber Decay

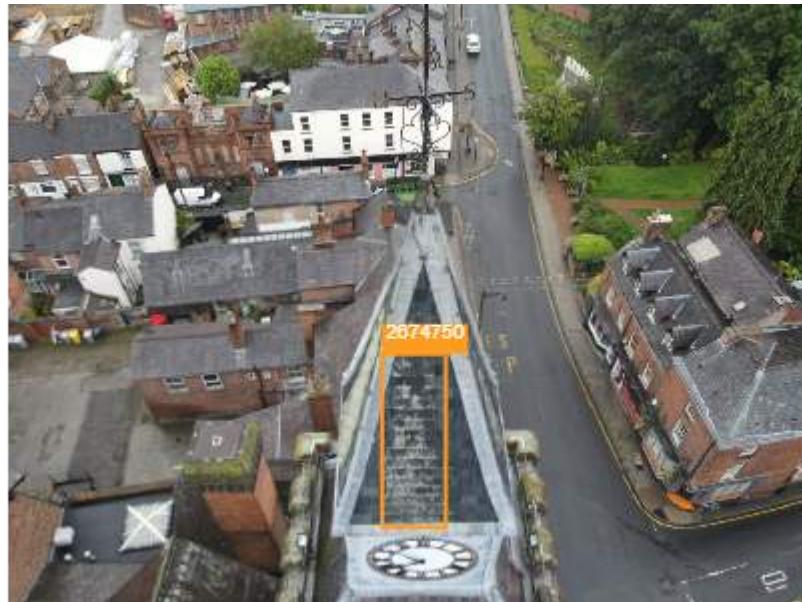
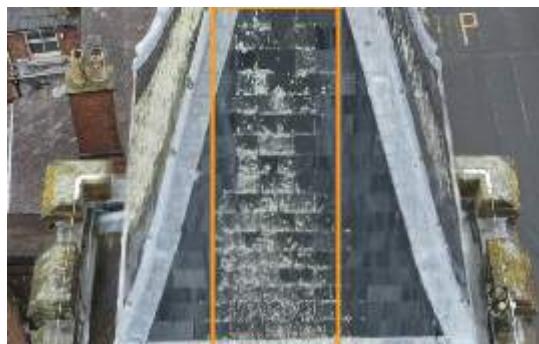
2674749 Severity: 3 Missing Slate

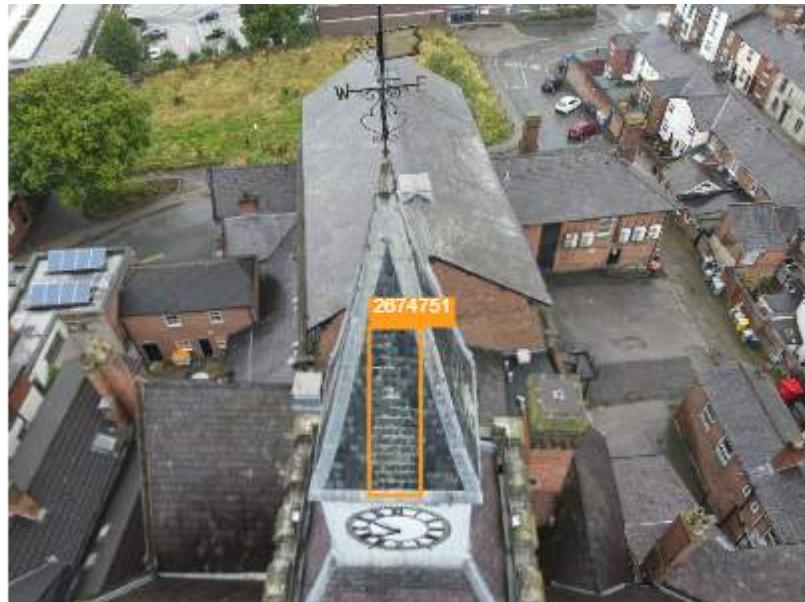
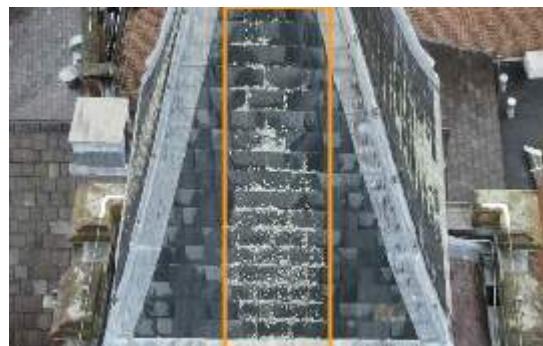
2674750 Severity: 1 Lichen Build Up

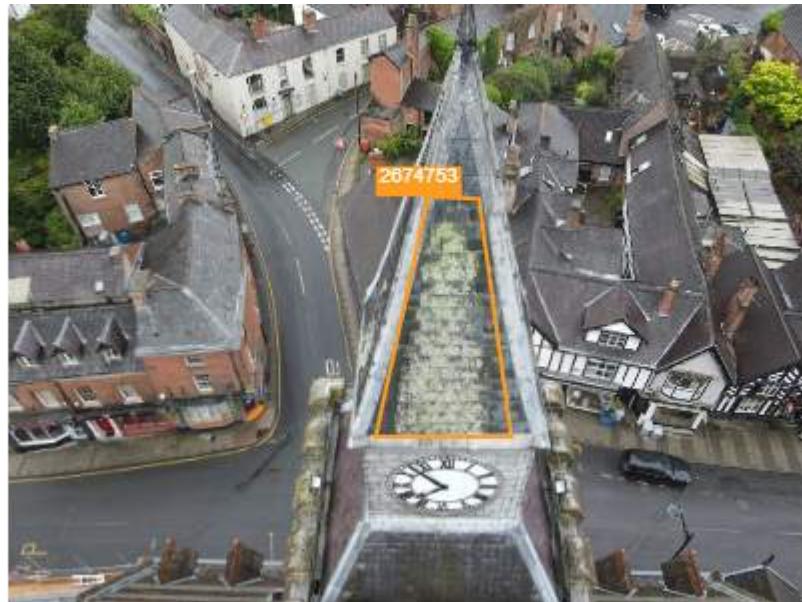
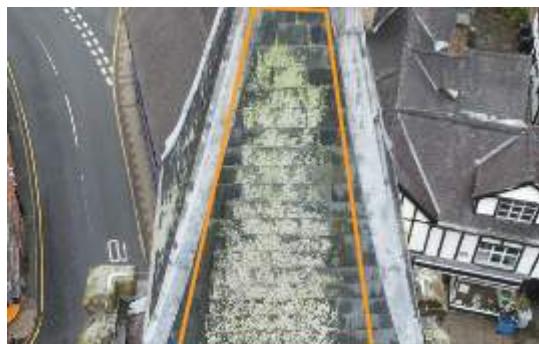
2674752 Severity: 1 Lichen Build Up

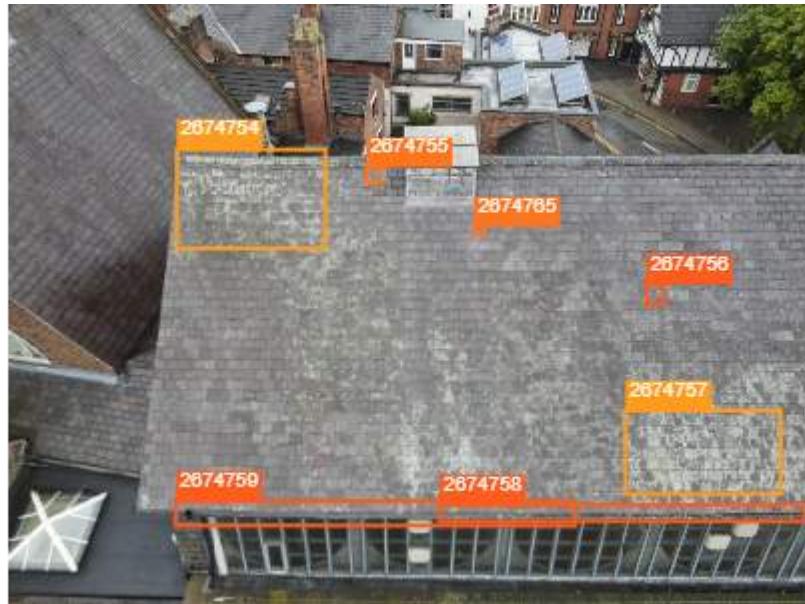
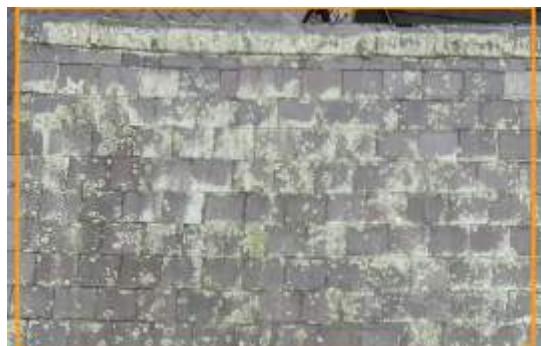
2674753 Severity: 1 Lichen Build Up

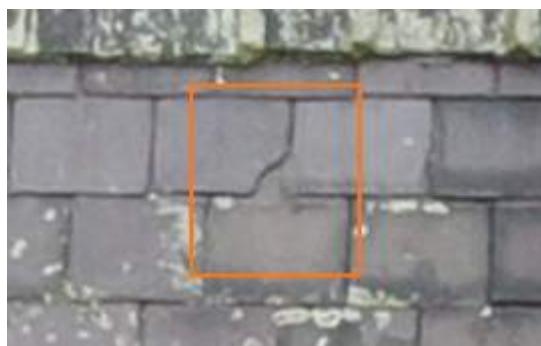
2674754 Severity: 1 Lichen Build Up

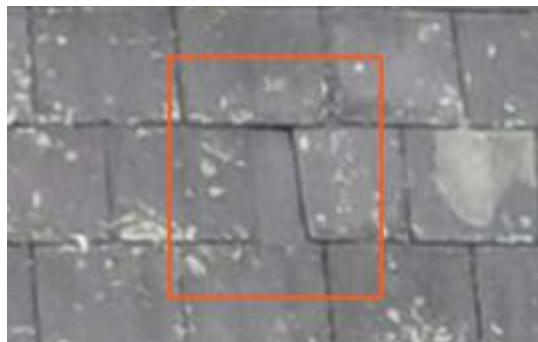
2674755 Severity: 2 Damaged Slate

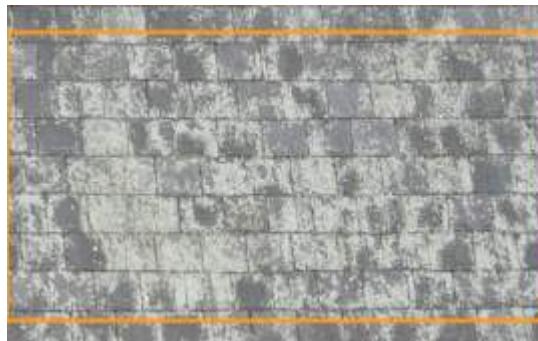
2674756 Severity: 3 Damaged Slate

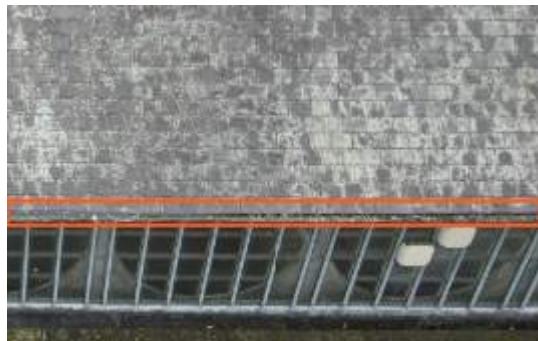
2674757 Severity: 1 Lichen Build Up

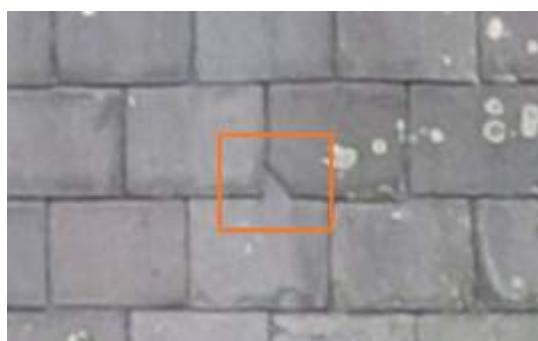
2674759 Severity: 3 Gutter Deformed

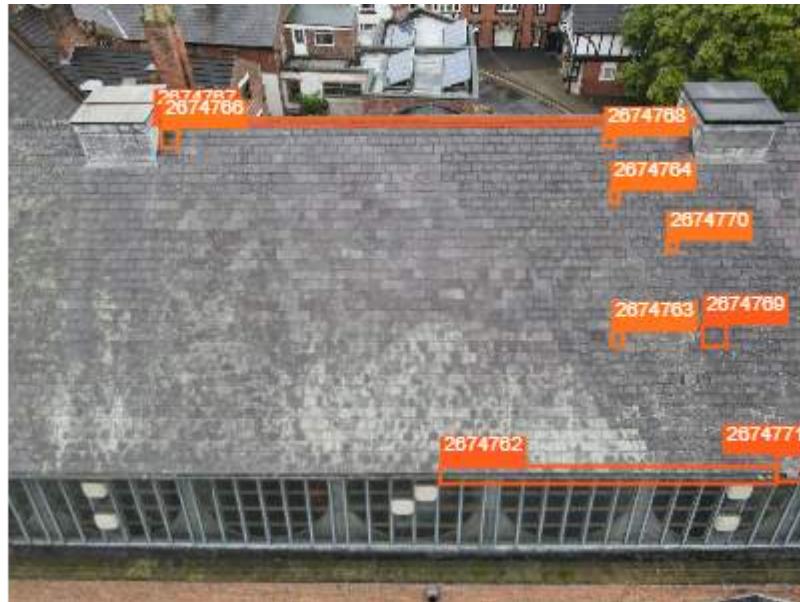
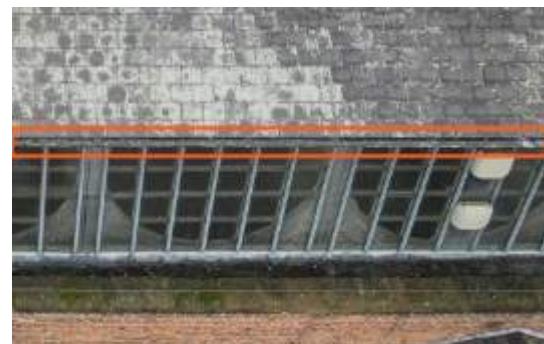
2674765 Severity: 2 Damaged Slate

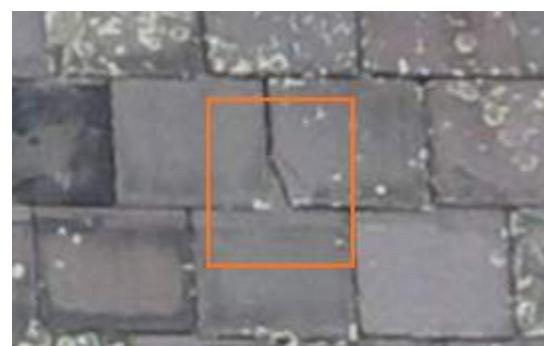
2674762 Severity: 3 Significant Debris in Gutter

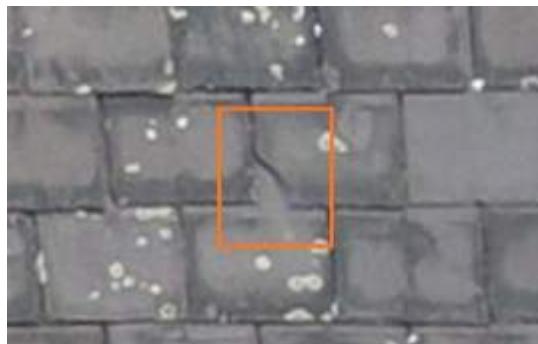
2674763 Severity: 2 Damaged Slate

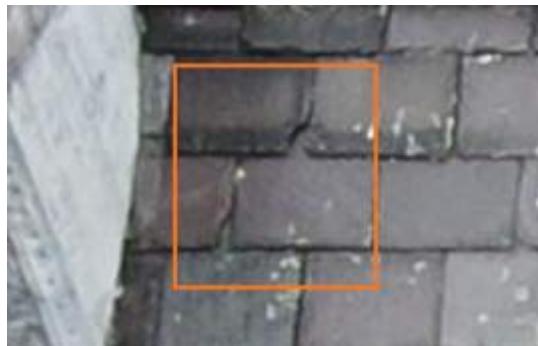
2674764 Severity: 2 Damaged Slate

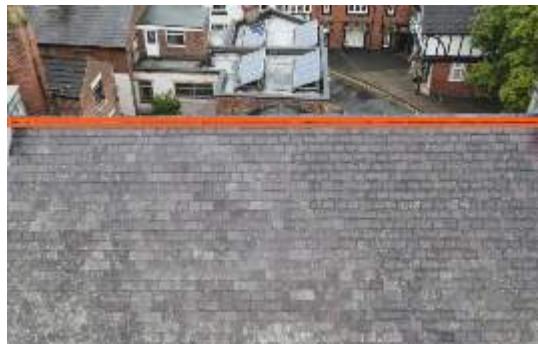
2674766 Severity: 2 Damaged Slate

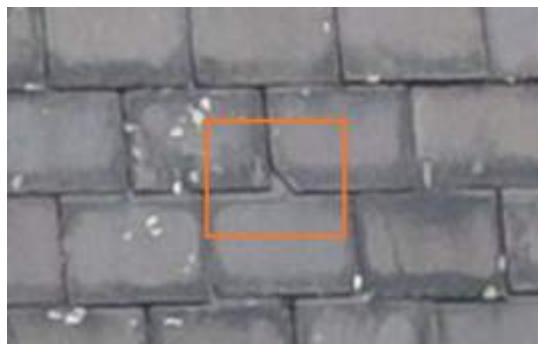
2674767 Severity: 3 Missing Mortar to Ridge

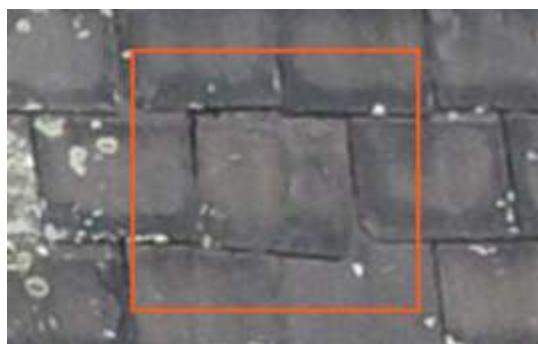
2674768 Severity: 2 Damaged Slate

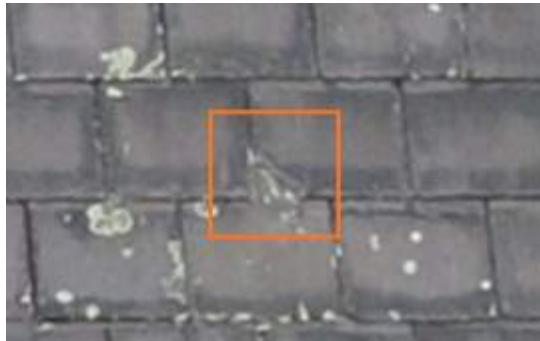
2674769 Severity: 3 Slipped Slate

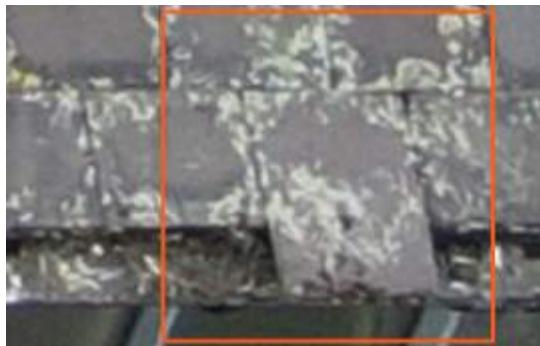
2674770 Severity: 2 Damaged Slate

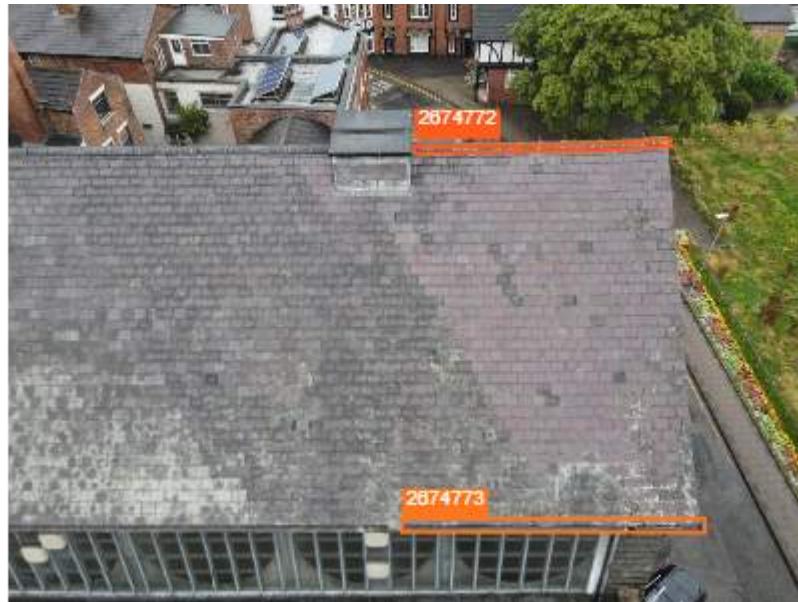
2674771 Severity: 3 Slipped Slate

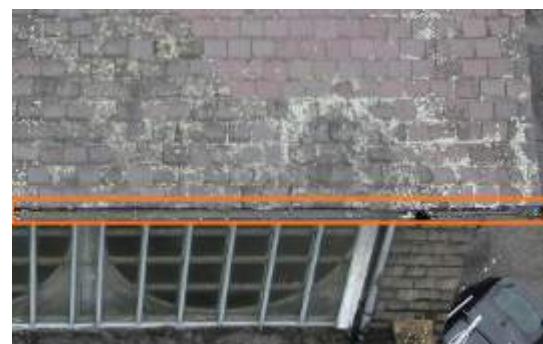
2674772 Severity: 3 Missing Mortar to Ridge

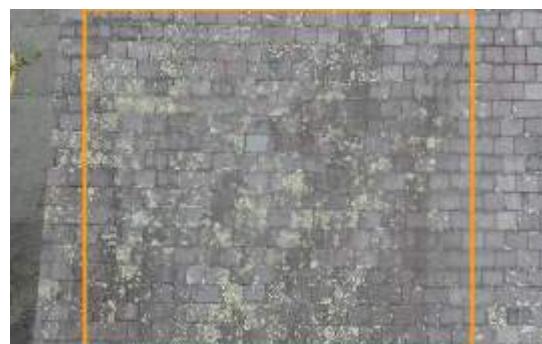
2674775 Severity: 2 Slate

**Neil Poynor**  
Alternating laps

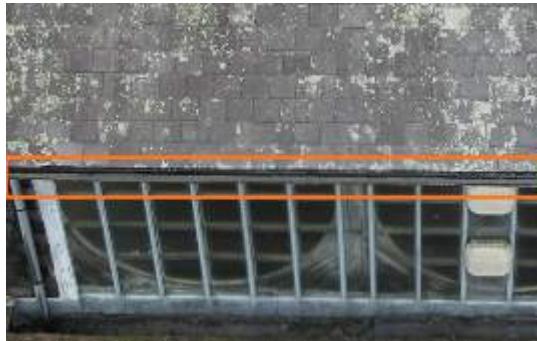
2674776 Severity: 1 Lichen Build Up

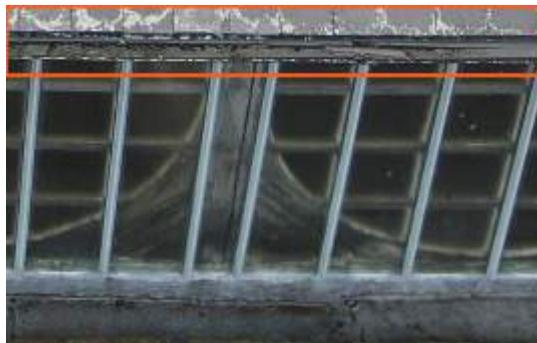
2674780 Severity: 2 Standing Water in Gutter

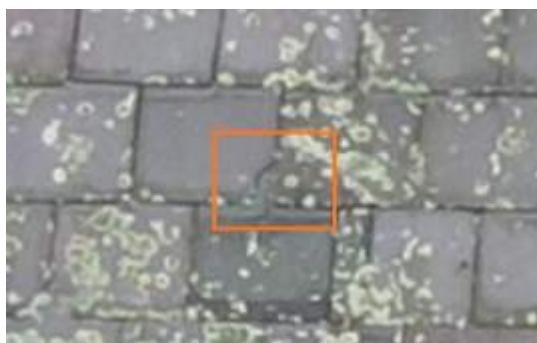
2674782 Severity: 2 Damaged Slate

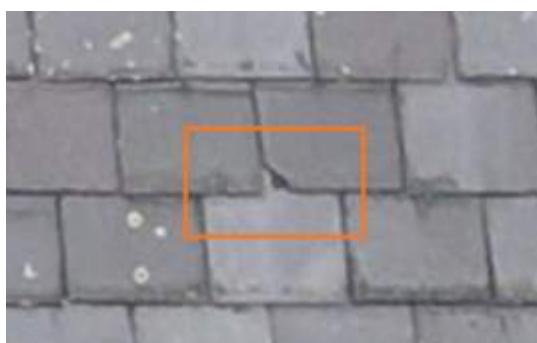
2674783 Severity: 2 Damaged Slate

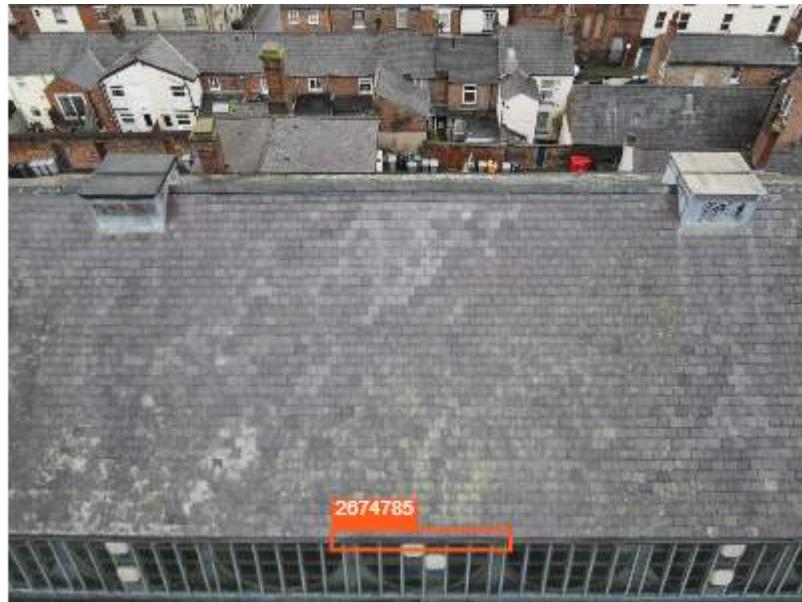
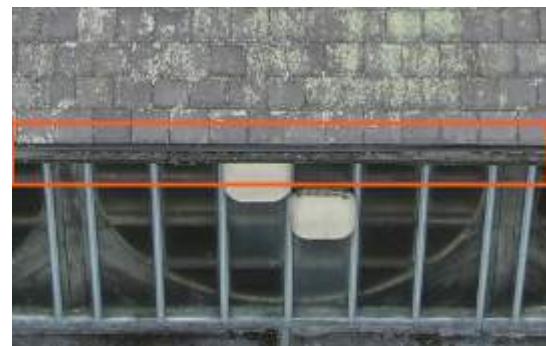
2674784 Severity: 2 Damaged Slate

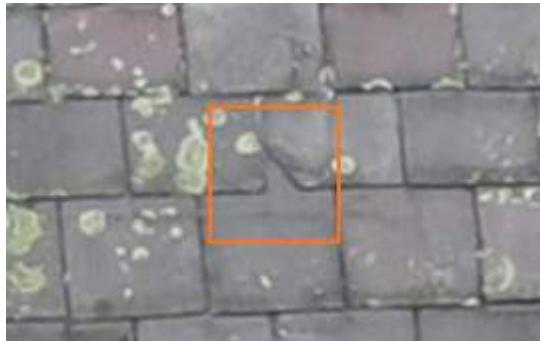
2674789 Severity: 2 Damaged Slate

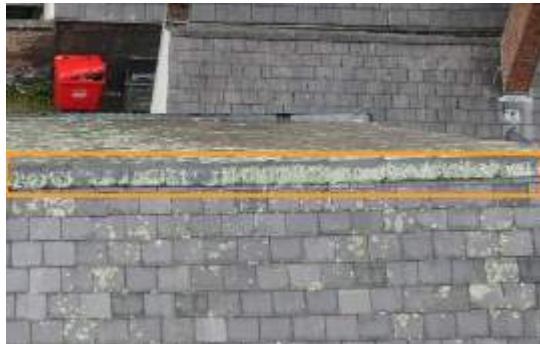
2674790 Severity: 1 Lichen Build Up

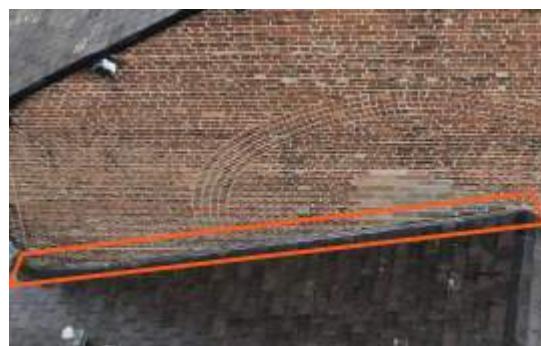
2674792 Severity: 3 Slate

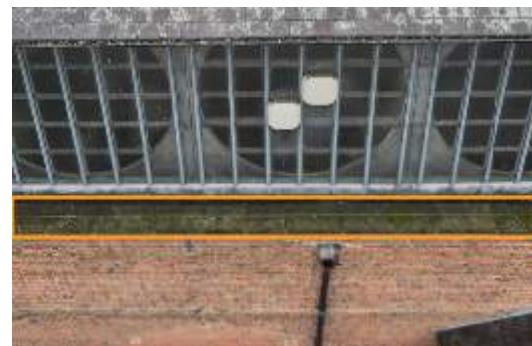
2674794 Severity: 1 Moss Growth

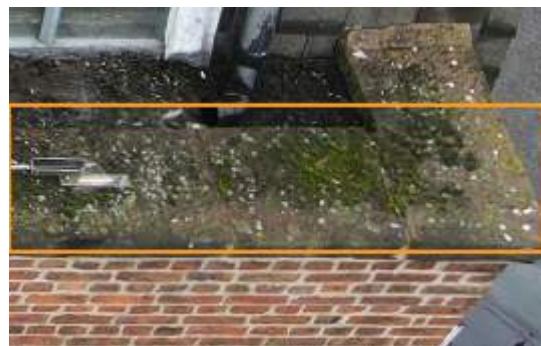
2674793 Severity: 1 Moss Growth

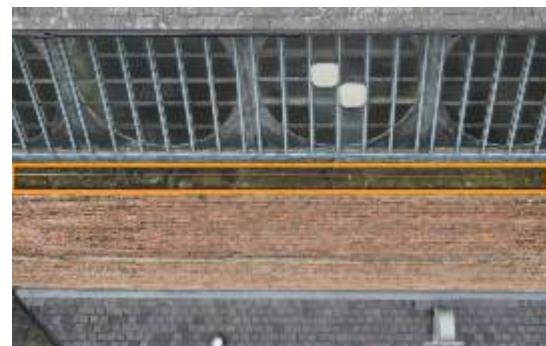
2674798 Severity: 1 Moss/Lichen Build Up

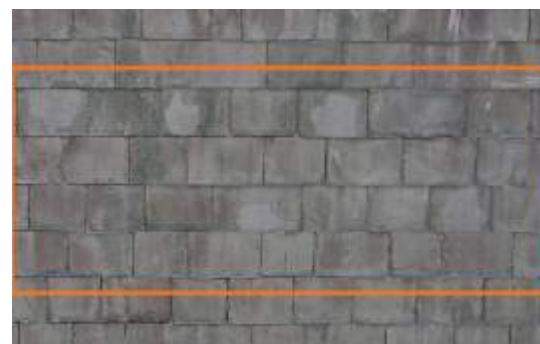
2674802 Severity: 2 Slate

**Neil Poynor**  
Slates laminating

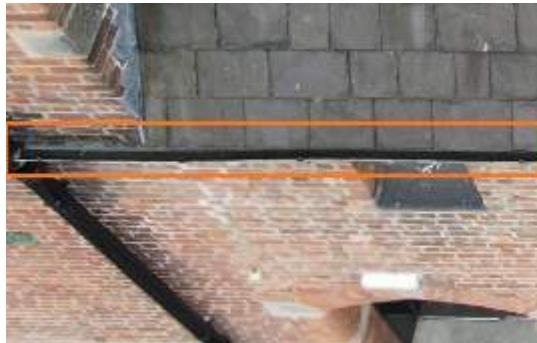
2674805 Severity: 2 Standing Water in Gutter

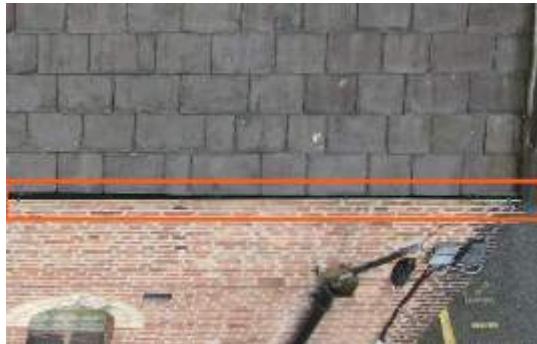
2674807 Severity: 3 Guttering

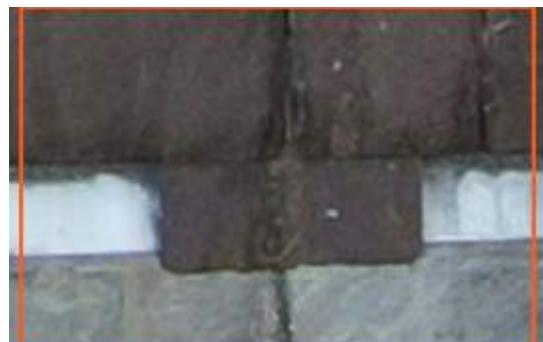
2674813 Severity: 3 Slipped Slate

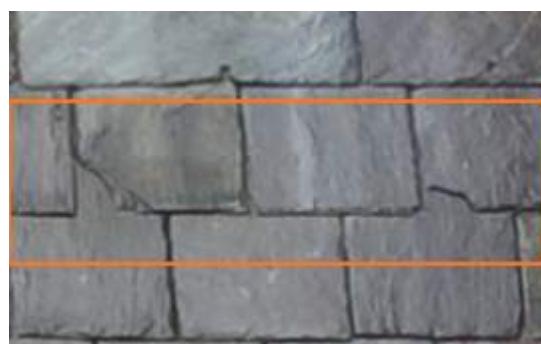
2674819 Severity: 2 Damaged Slate

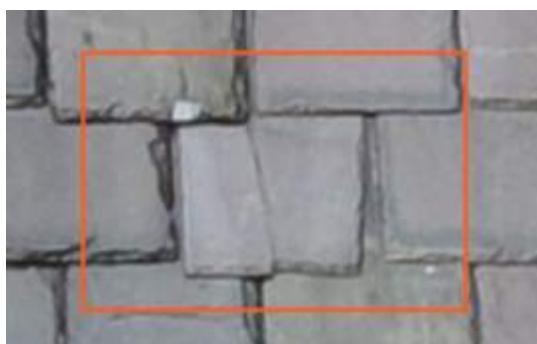
2674822 Severity: 3 Damaged Slate

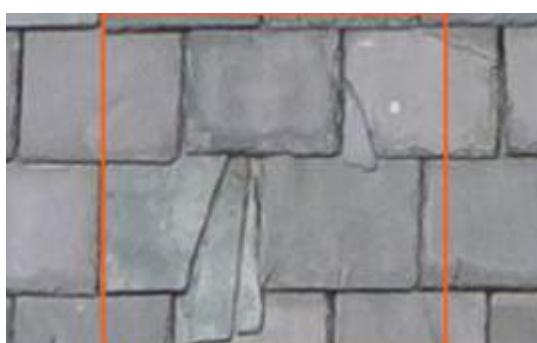
2674824 Severity: 3 Damaged Slate

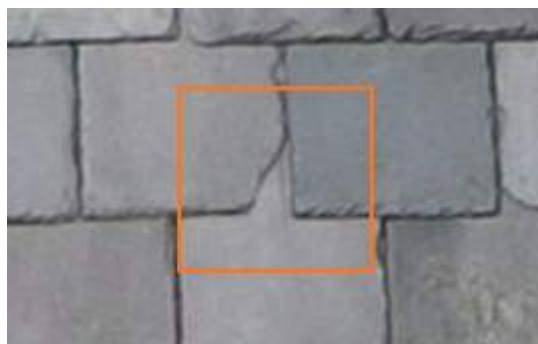
2674826 Severity: 2 Damaged Slate

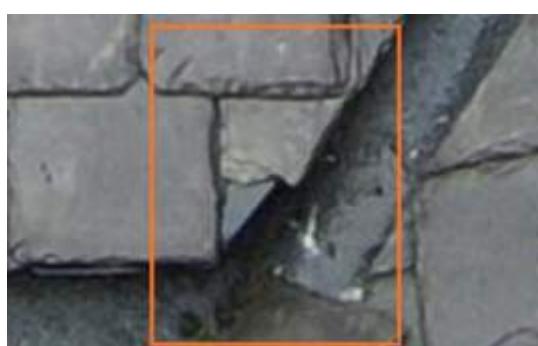
2674828 Severity: 2 Damaged Slate

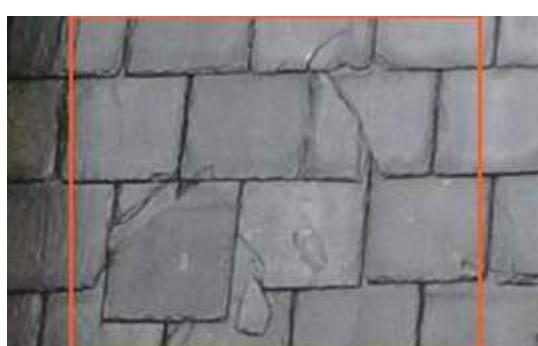
2674830 Severity: 3 Damaged Slate

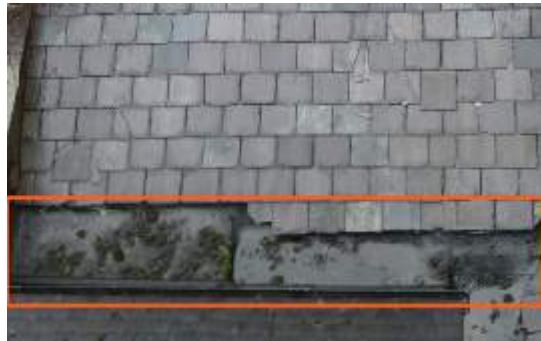
2674831 Severity: 3 Minor Debris in Gutter

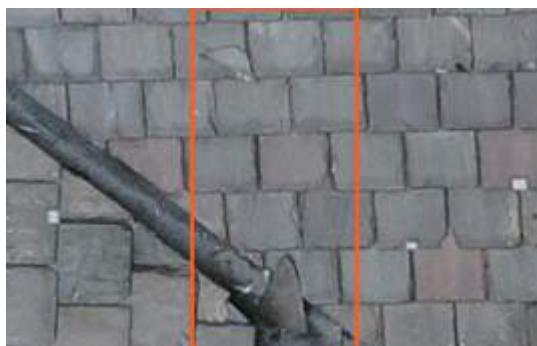
2674843 Severity: 3 Loose Object
