## **CONGLETON TOWN COUNCIL**

| <b>REPORT FROM</b> | <b>Town Hall Manager – Mark Worthington</b> | | |
| <b>REPORT TITLE</b> | <b>Roof Repairs Drone Survey (i)</b> | | |

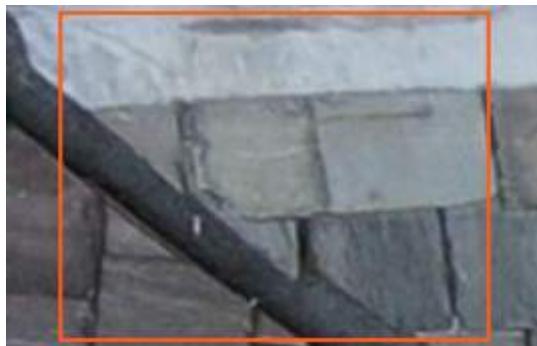
2674844 Severity: 3 Slipped Slate

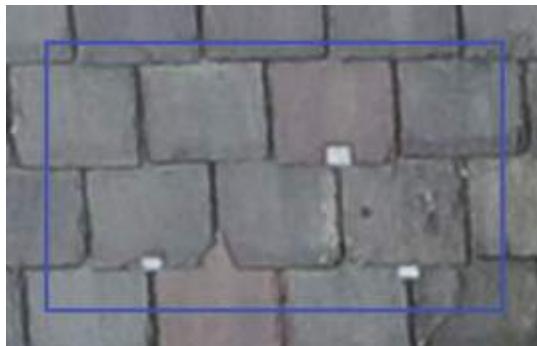
2674845 Severity: 0 Historic Repair

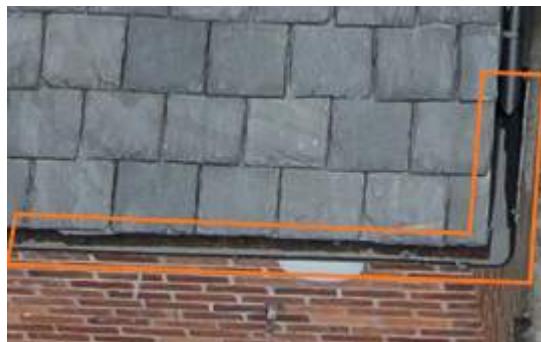
2675505 Severity: 2 Standing Water in Gutter

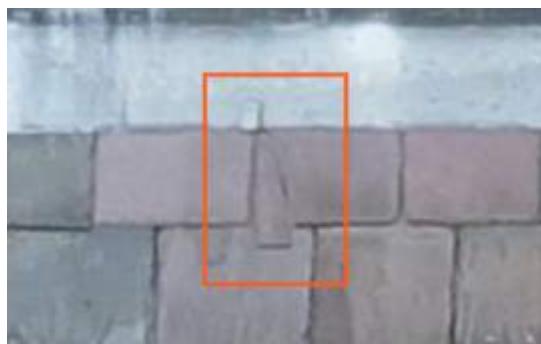
2675530 Severity: 3 Damaged Slate

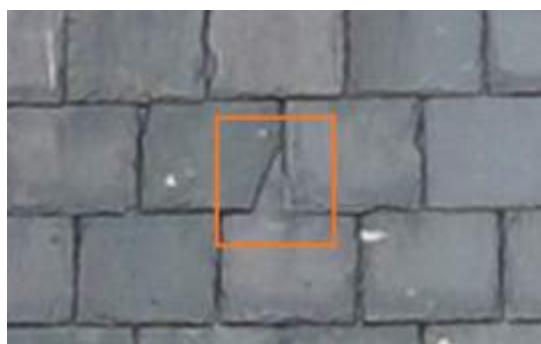
2675533 Severity: 2 Damaged Slate

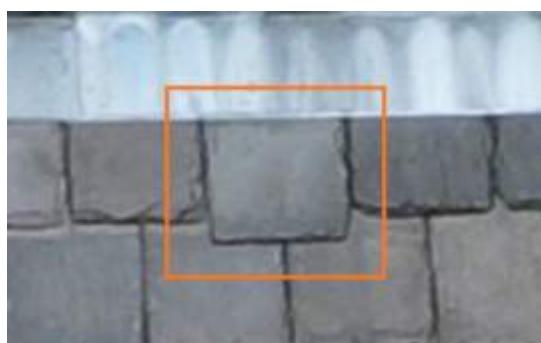
2675535 Severity: 2 Slipped Slate

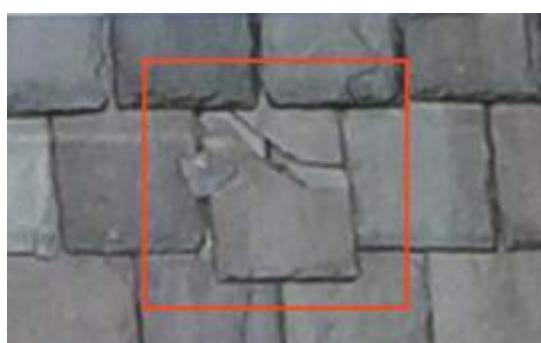
2675536 Severity: 4 Damaged Slate

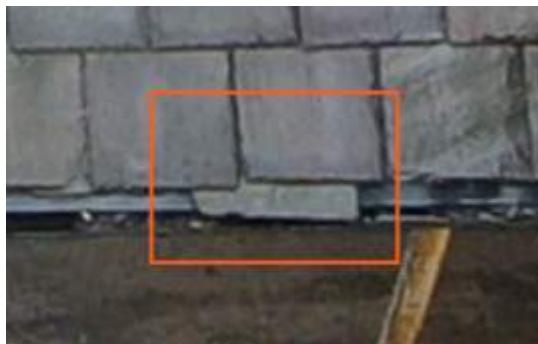
2675537 Severity: 3 Slipped Slate

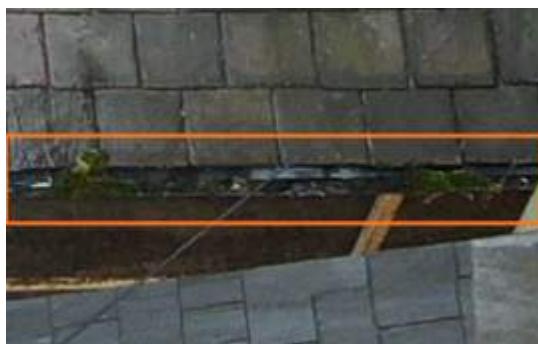
2675538 Severity: 2 Moss Growth

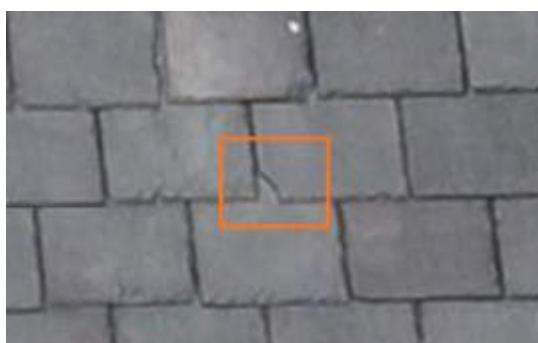
2675543 Severity: 2 Damaged Slate

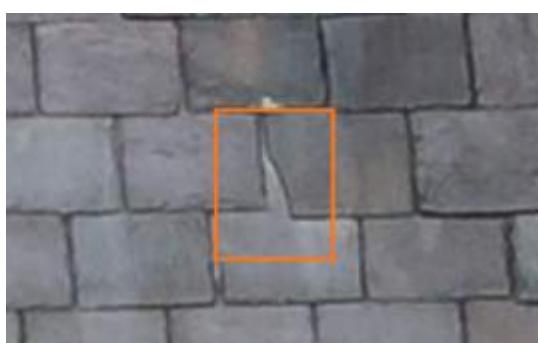
2675546 Severity: 2 Damaged Slate

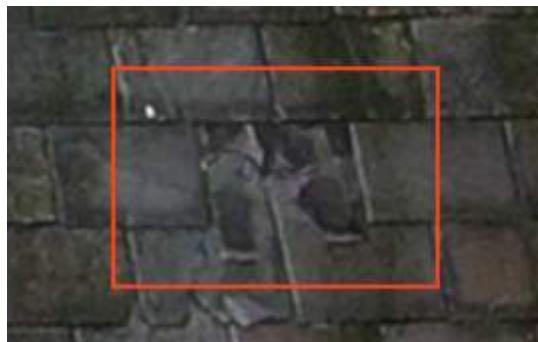
2675550 Severity: 4 Damaged Slate

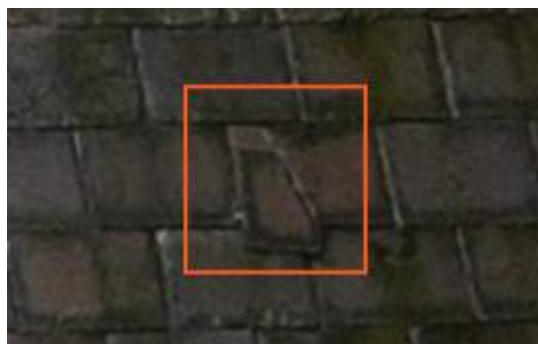
2675551 Severity: 3 Damaged Slate

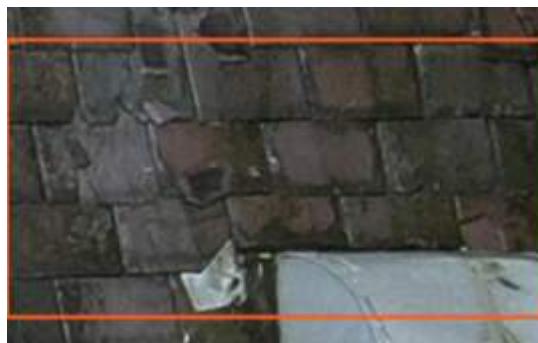
2675552 Severity: 3 Damaged Slate

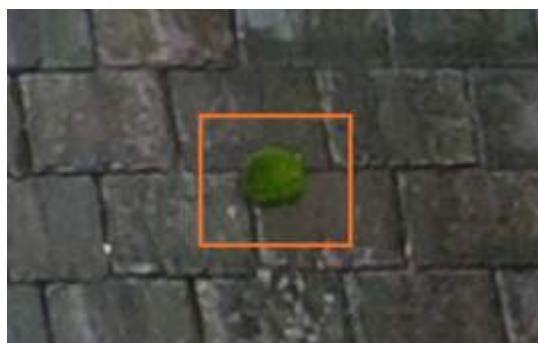
2675556 Severity: 2 Moss Growth

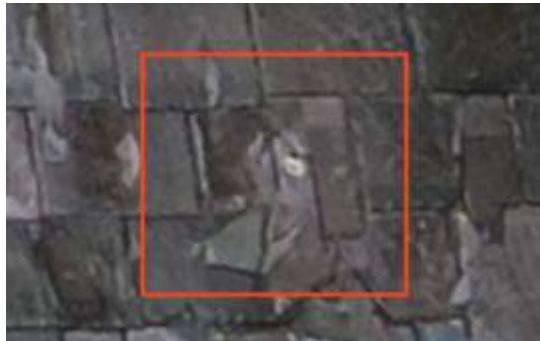
2675562 Severity: 4 Damaged Slate

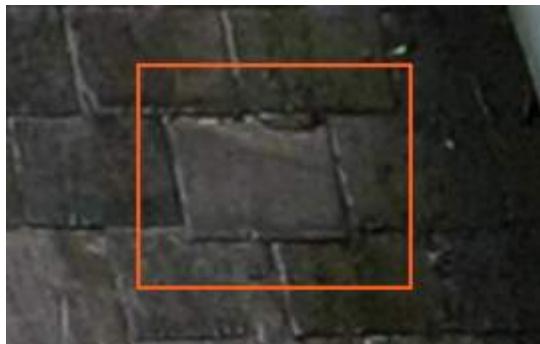
2675566 Severity: 3 Slipped Slate

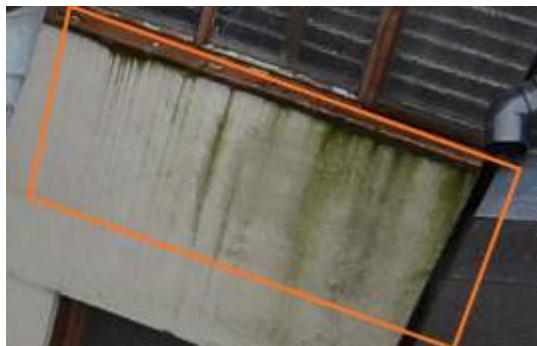
2675598 Severity: 2 Algae

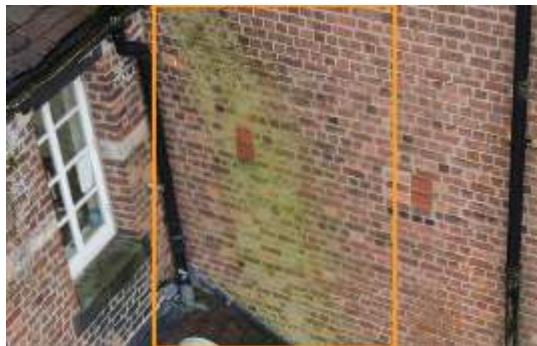
2675604 Severity: 1 Algae

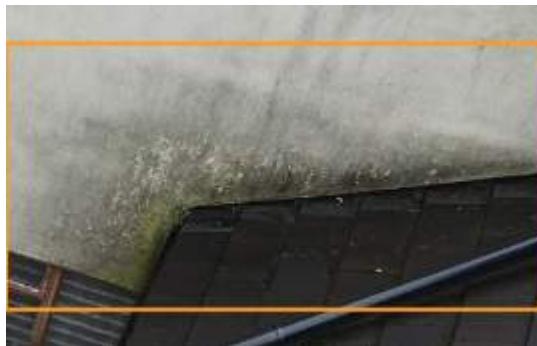
2675621 Severity: 1 Staining

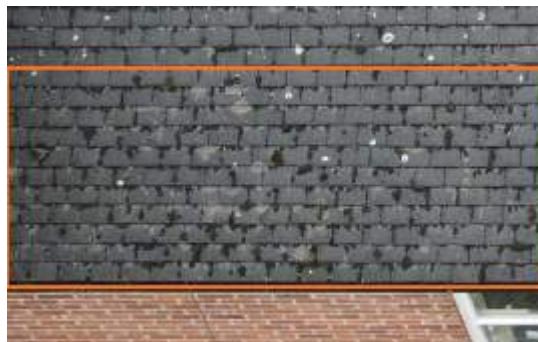
2675641 Severity: 2 Moss Growth

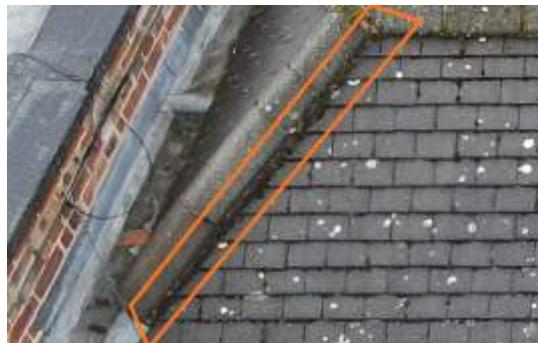
2675651 Severity: 2 Moss Growth

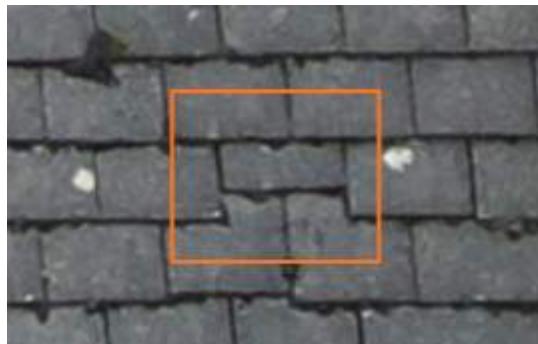
2675663 Severity: 2 Tile

Tile pushed up

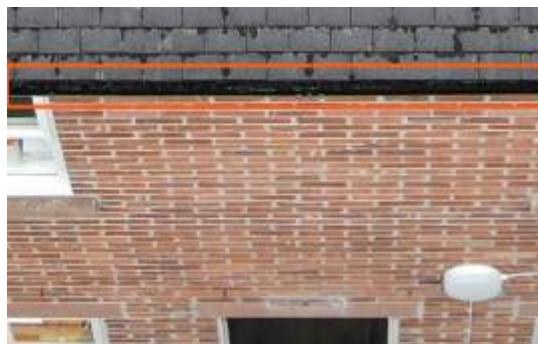
2675666 Severity: 3 Minor Debris in Gutter

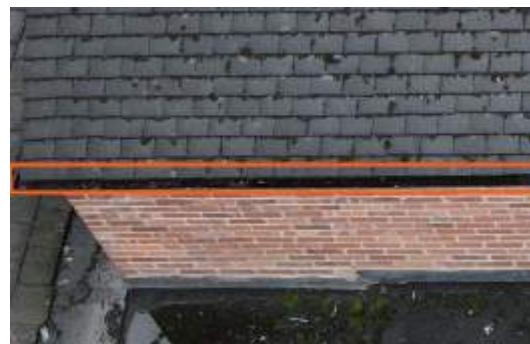
2675669 Severity: 3 Minor Debris in Gutter

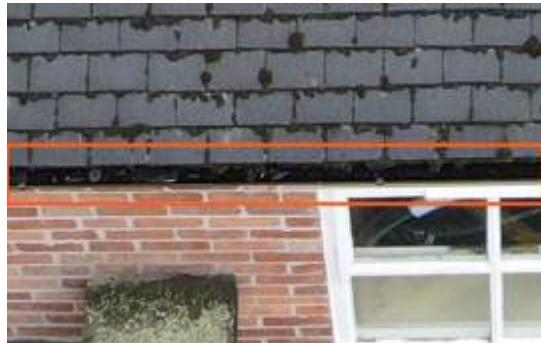
2675681 Severity: 3 Minor Debris in Gutter

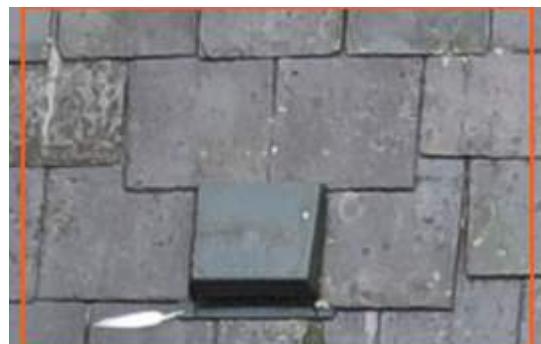
2675712 Severity: 3 Slipped Slate

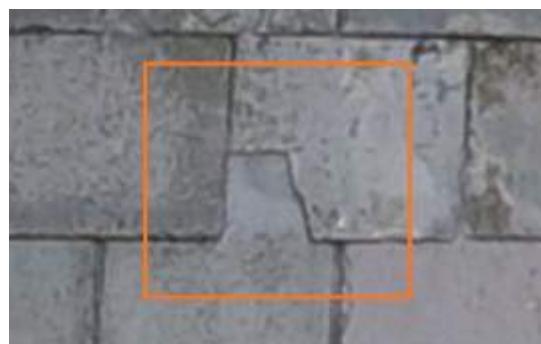
2675713 Severity: 2 Damaged Slate

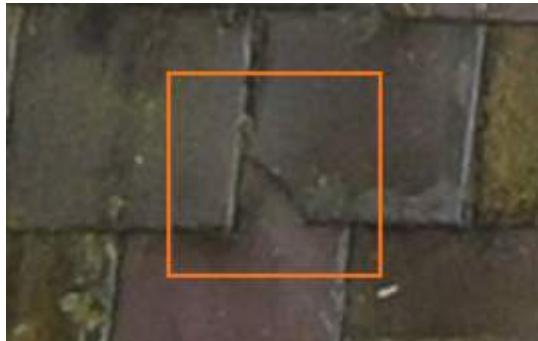
2675714 Severity: 2 Damaged Slate

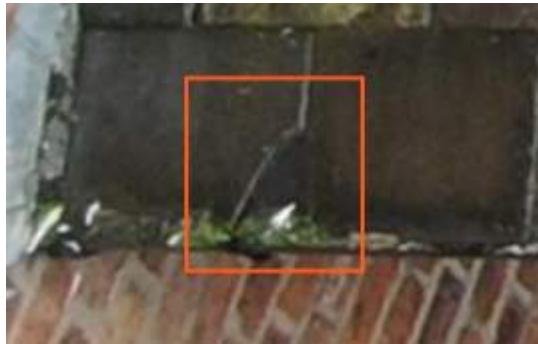
2675715 Severity: 3 Damaged Slate

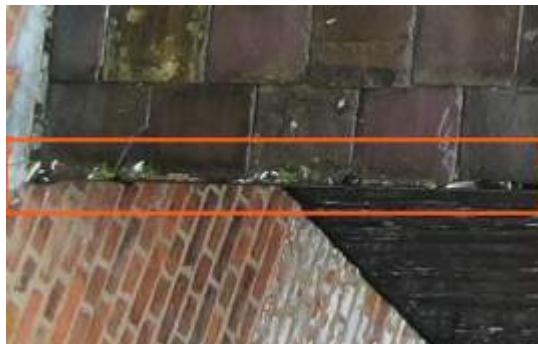
2675716 Severity: 3 Significant Debris in Gutter

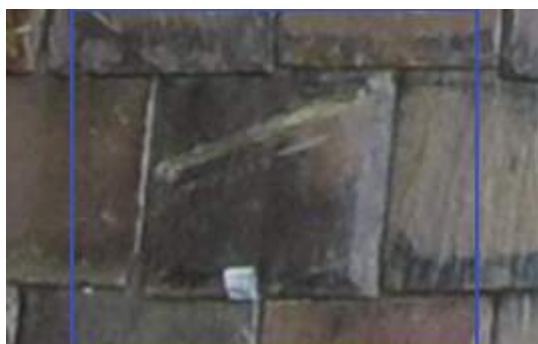
2675730 Severity: 0 Historic Repair

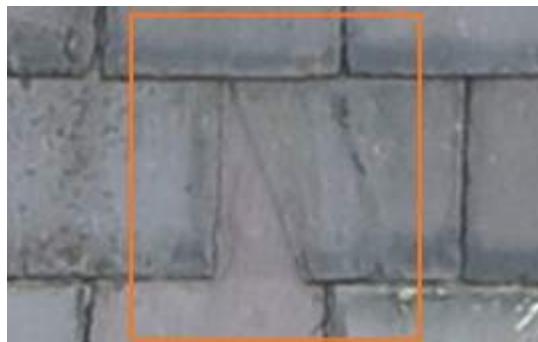
2675735 Severity: 2 Damaged Slate

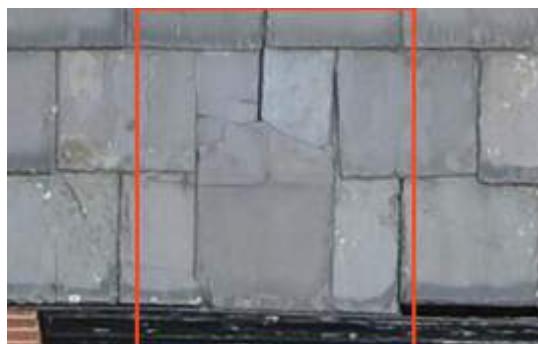
2675739 Severity: 4 Damaged Slate

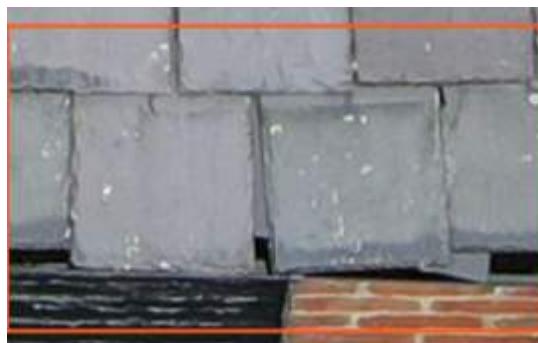
2675744 Severity: 3 Slipped Slate

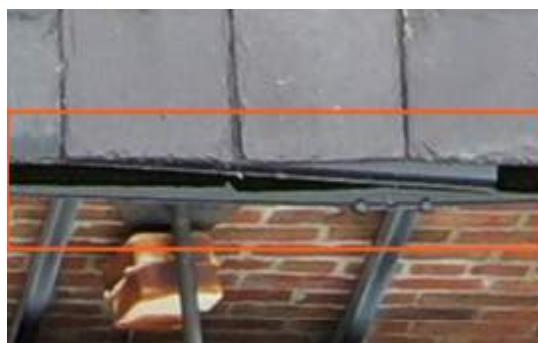
2675749 Severity: 3 Loose Object

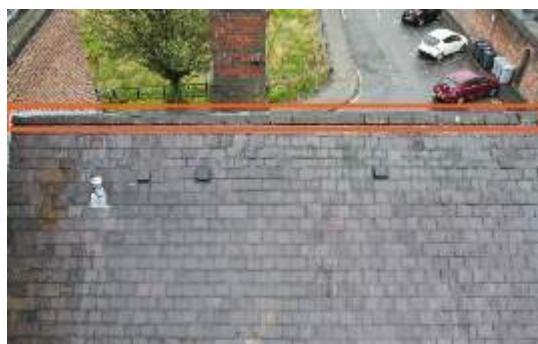
2675760 Severity: 3 Missing Mortar to Ridge

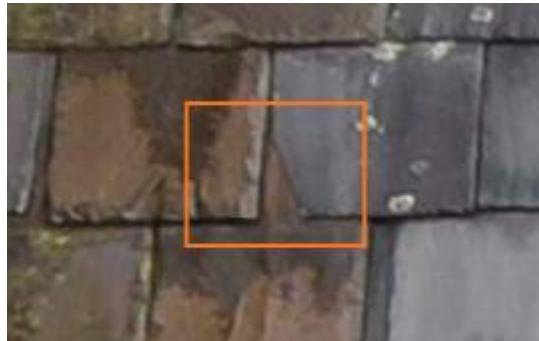
2675762 Severity: 2 Damaged Slate

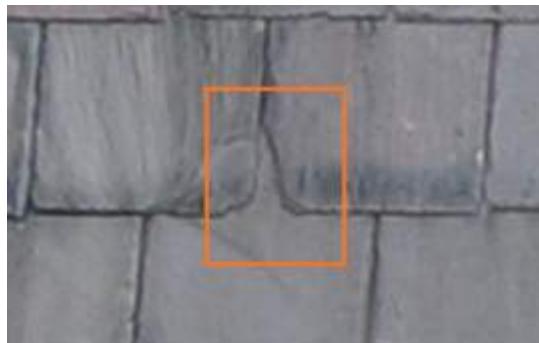
2675764 Severity: 2 Damaged Slate

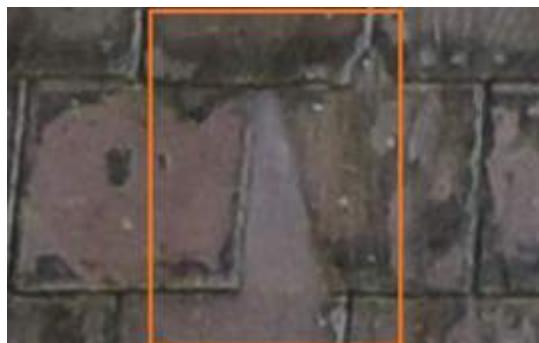
2675768 Severity: 2 Damaged Slate

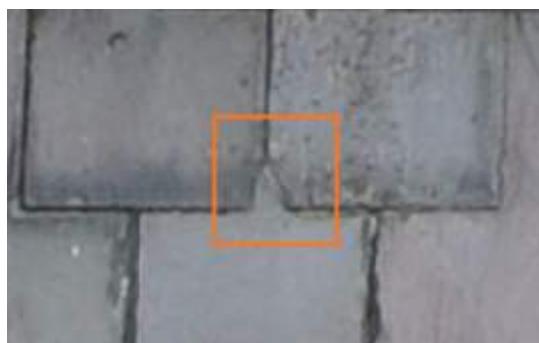
2675771 Severity: 2 Damaged Slate

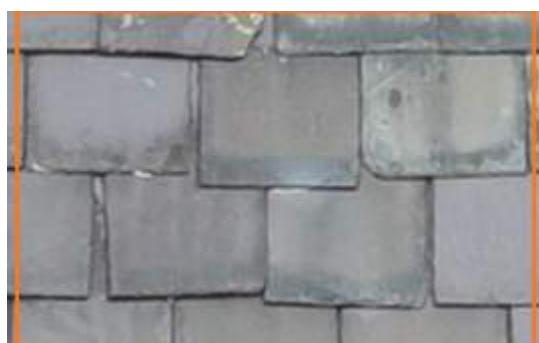
2675776 Severity: 2 Misaligned Slate

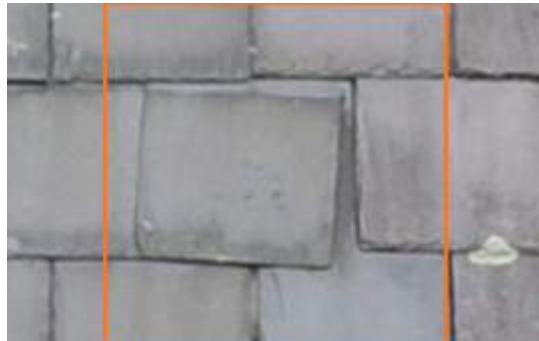
2675783 Severity: 2 Misaligned Slate

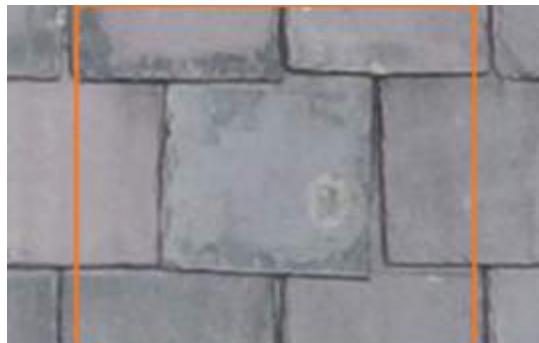
2675786 Severity: 2 Misaligned Slate

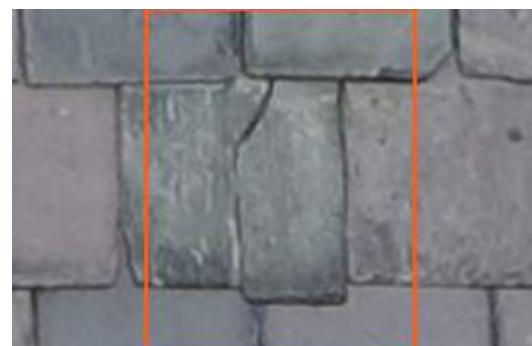
2675794 Severity: 3 Damaged Slate

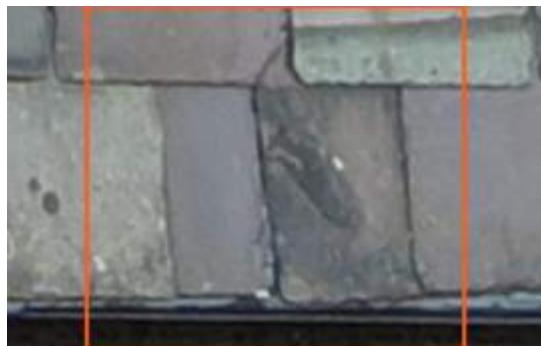
2675804 Severity: 3 Damaged Slate

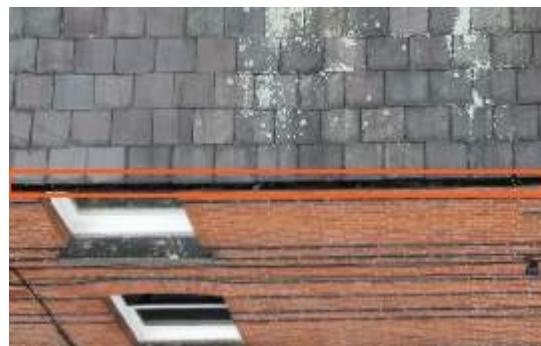
2675812 Severity: 3 Significant Debris in Gutter

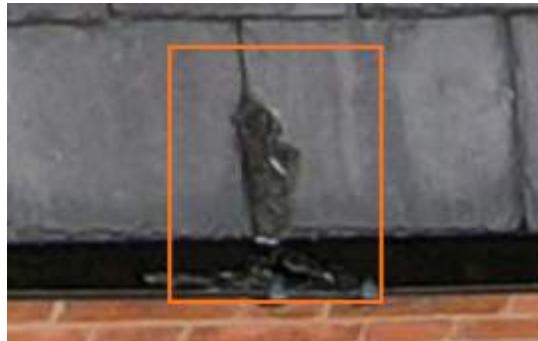
2675820 Severity: 2 Debris

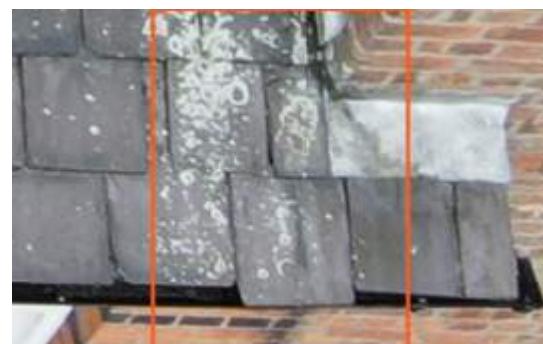
2675844 Severity: 3 Slipped Slate

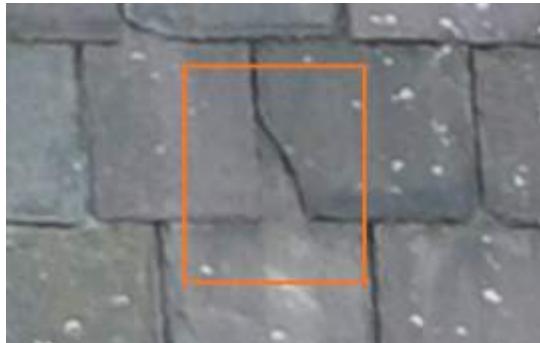
| <b>Id</b> | <b>Image name</b> | <b>Severity</b> | <b>Issues</b> | <b>Comments</b> | <b>Page</b> |
|---|---|---|---|---|---|
| 2675846 | 200754 (96).JPG | 2 | Damaged Slate | | <a href="#">112</a> |

2675846 Severity: 2 Damaged Slate

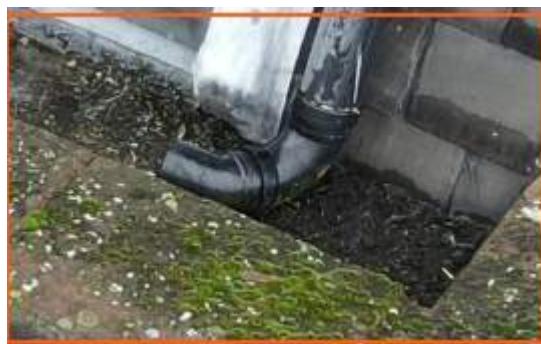
2675853 Severity: 3 Significant Debris in Gutter

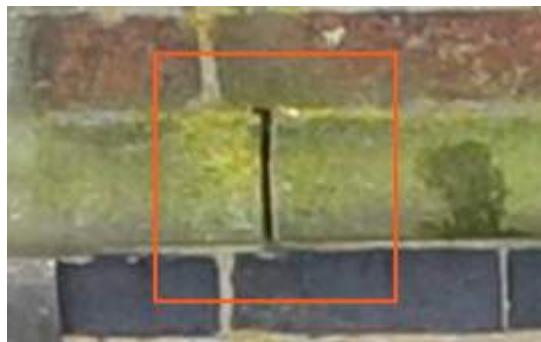
| <b>Id</b> | <b>Image name</b> | <b>Severity</b> | <b>Issues</b> | <b>Comments</b> | <b>Page</b> |
|---|---|---|---|---|---|
| 2675863 | 200754 (98).JPG | 3 | Missing Mortar | | <a href="#">115</a> |

2675863 Severity: 3 Missing Mortar

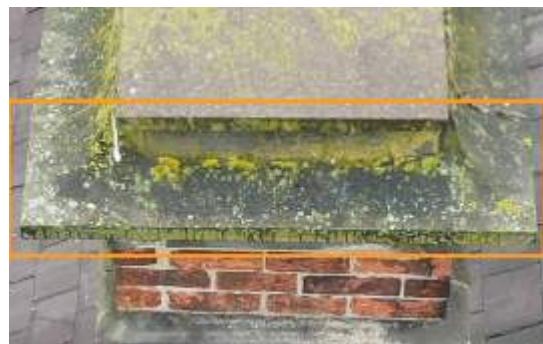
2675868 Severity: 1 Lichen Build Up

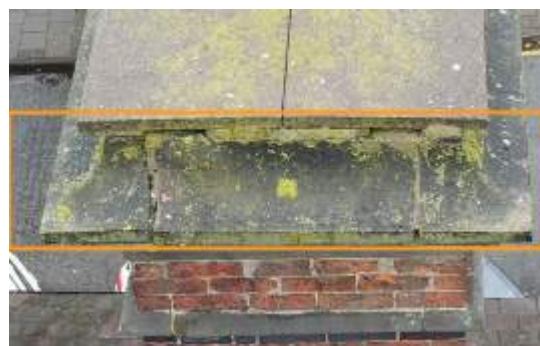
2675874 Severity: 1 Lichen Build Up

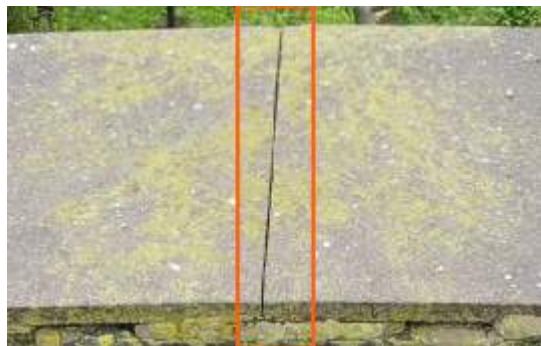
| <b>Id</b> | <b>Image name</b> | <b>Severity</b> | <b>Issues</b> | <b>Comments</b> | <b>Page</b> |
|---|---|---|---|---|---|
| 2675879 | 200754 (100).JPG | 3 | Missing Mortar | | <a href="#">118</a> |

2675879 Severity: 3 Missing Mortar

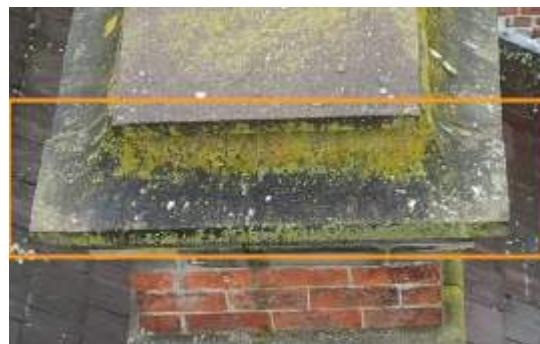
2675885 Severity: 1 Lichen Build Up

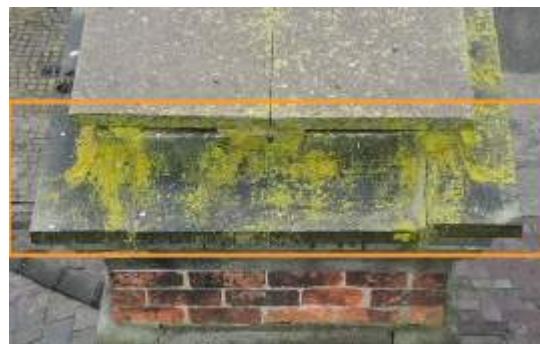
2675889 Severity: 1 Lichen Build Up

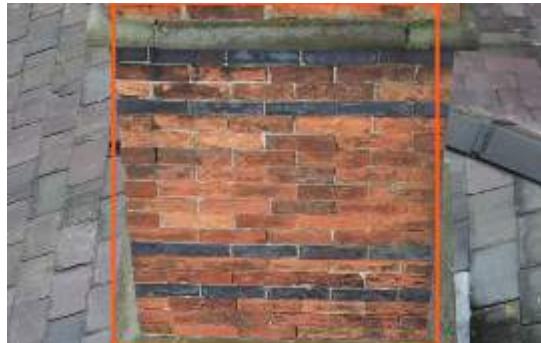
| <b>Id</b> | <b>Image name</b> | <b>Severity</b> | <b>Issues</b> | <b>Comments</b> | <b>Page</b> |
|---|---|---|---|---|---|
| 2675892 | 200754 (102).JPG | 3 | Missing Mortar | | <a href="#">121</a> |

2675892 Severity: 3 Missing Mortar

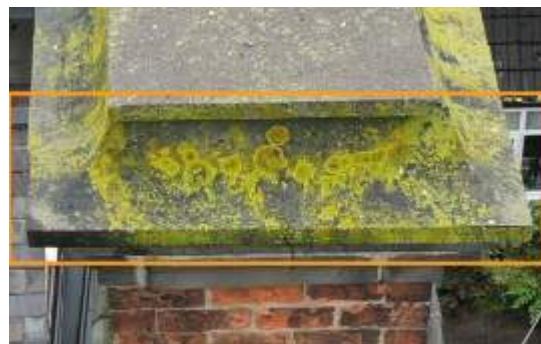
2675894 Severity: 1 Lichen Build Up

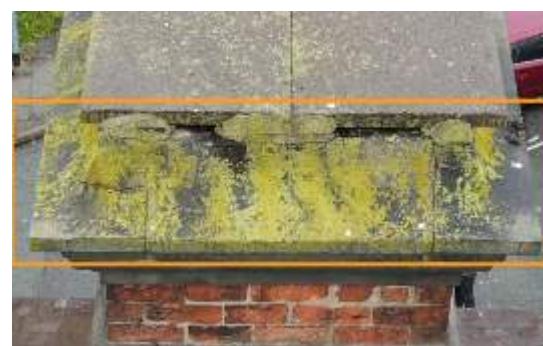
2675896 Severity: 1 Lichen Build Up

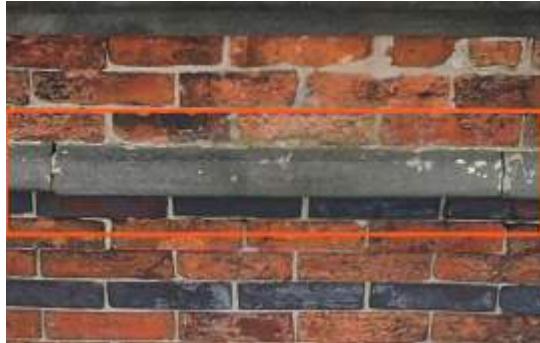
| <b>Id</b> | <b>Image name</b> | <b>Severity</b> | <b>Issues</b> | <b>Comments</b> | <b>Page</b> |
|---|---|---|---|---|---|
| 2675897 | 200754 (104).JPG | 3 | Missing Mortar | | <a href="#">124</a> |

2675897 Severity: 3 Missing Mortar

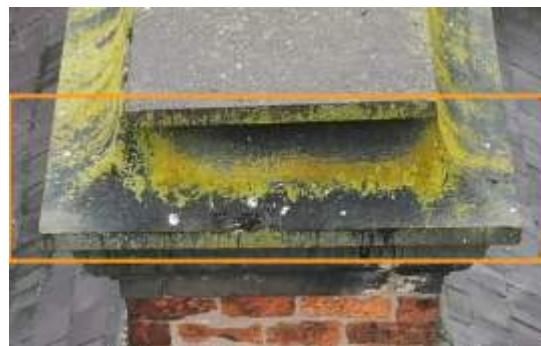
2675898 Severity: 1 Lichen Build Up

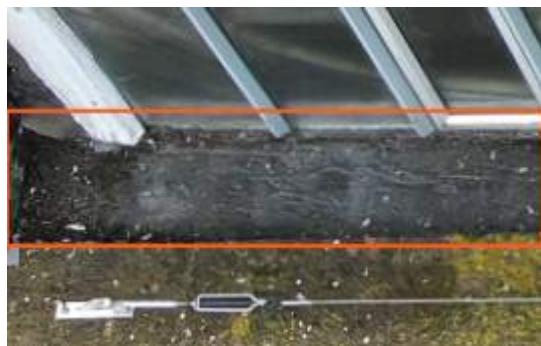
2675906 Severity: 3 Minor Debris in Gutter

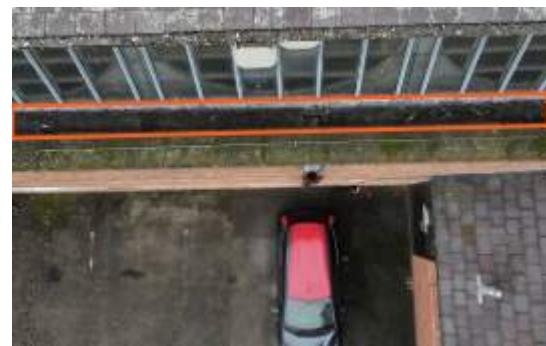
2675908 Severity: 3 Minor Debris in Gutter

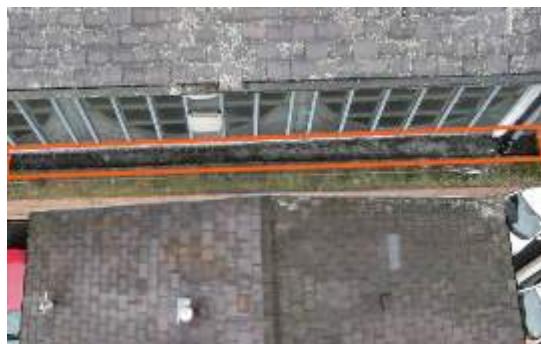
2675909 Severity: 3 Minor Debris in Gutter

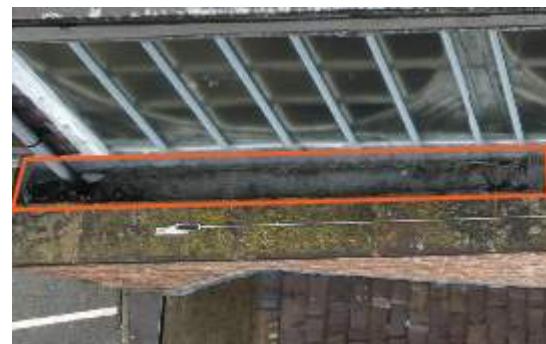
2675910 Severity: 3 Minor Debris in Gutter

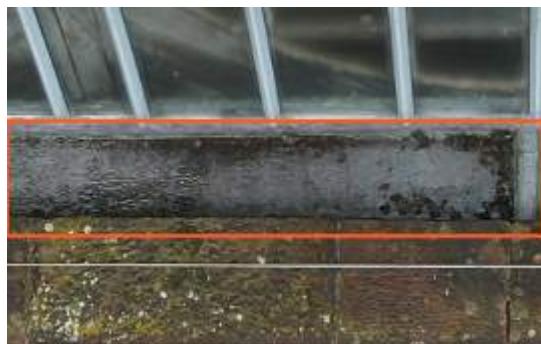
2675911 Severity: 3 Minor Debris in Gutter

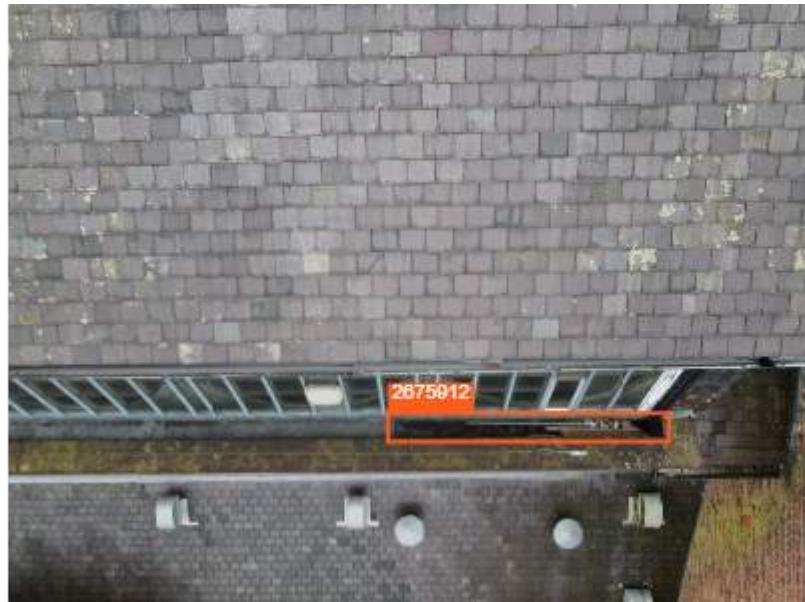
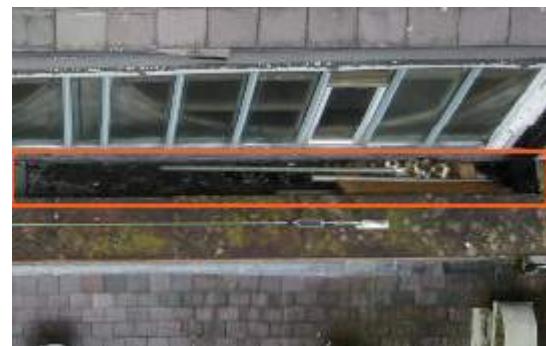
2675912 Severity: 3 Significant Debris in Gutter

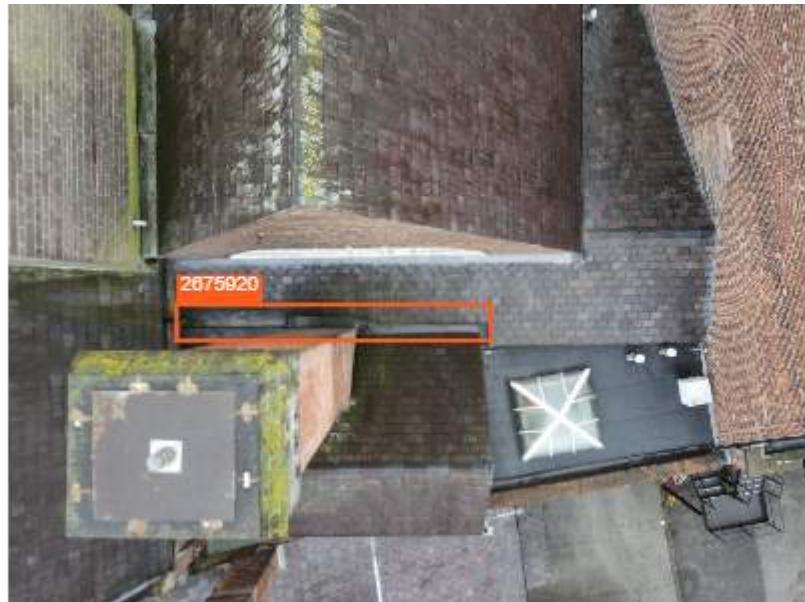
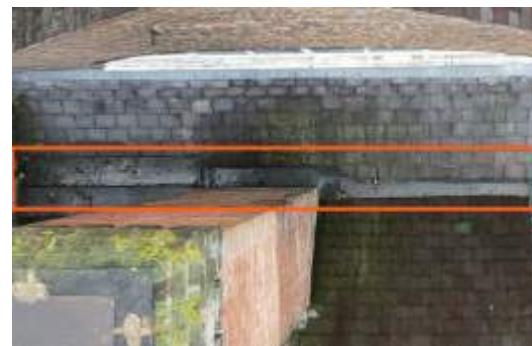
2675920 Severity: 3 Minor Debris in Gutter
